Access Compliance Report

Public Rights-of-Way

(Curb Ramps)

Intersection ID: 15988	Main Street: SOUTH_BV	Cross Street: HOLLIS_RD	Location: SE
ADA ID: CAB8DF51F8A1	Ramp Type: PerpDiag	Initial Pass/Fail: Fail	Overall Compliance: No
		Severity Score: 10

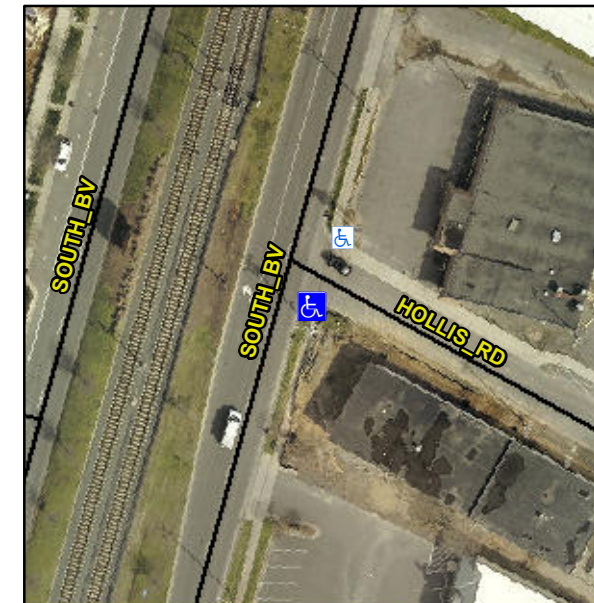
Not Found, R304.5.1, R304.5.3

Compliance	Description	Data	Compliance	Description	Data
N/A	Ramp Length (in)	81.0	Yes	Ramp Slope (%)	5.0
No	Ramp Width (in)	42.0	No	Ramp XSlope (%)	4.2
N/A	Flare Type LT	N/A	N/A	Flare Type RT	N/A
N/A	Flare Slope LT (%)	N/A	N/A	Flare Slope RT (%)	N/A
N/A	Flare Traversable LT?	N/A	N/A	Flare Traversable RT?	N/A
N/A	Landing Length (in)	N/A	N/A	DWS Provided?	N/A
N/A	Landing Width (in)	N/A	N/A	DWS Contrast?	N/A
N/A	Landing Slope (%)	N/A	N/A	DWS Length (in)	N/A
N/A	Landing X Slope (%)	N/A	N/A	DWS Full Width?	N/A
N/A	Landing Curb? (Y/N)	N/A	N/A	DWS Offset (in)	N/A
N/A	Shared Landing?	N/A			
N/A	Gutter Ponding?	N/A	N/A	Gutter Slope (%)	N/A
N/A	Gutter Lip Ht (in)	N/A	N/A	Gutter X Slope (%)	N/A
N/A	Painted X Walk1?	No	N/A	Painted X Walk2?	No
	X Walk 1 Direction	To NE		X Walk 2 Direction	To NW
N/A	X Walk 1 Width (in)	N/A	N/A	X Walk 2 Width (in)	N/A
	X Walk 1 Slope (%)	1.9		X Walk 2 Slope (%)	2.0
	X Walk 1 X Slope (%)	0.3		X Walk 2 X Slope (%)	6.6

N/A	Ramp inside XWalk1?	N/A	N/A	Ramp inside XWalk2?	N/A
	Road Slope (%)	0.2	N/A	Clear Space?	N/A
	Road X Slope (%)	4.6	N/A	Clear Space to XWalk (in)	N/A
N/A	Any Obstructions?	N/A	N/A	Storm Grate/Utility Hazard?	N/A
	Obstruction Type			Storm Grate/Utility Type	
		N/A			N/A
			Yes	Surface Condition? (G/P)	Good

Remove & Replace Curb Ramp With Two New Directional Ramps or Equivalent.

Total Cost: \$ 3200.00
