# Access Compliance Report

## Public Rights-of-Way

### (Curb Ramps)

| Intersection ID: 2813 | Main Street: RIDGEFIELD_DR | Cross Street: SWANSTON_DR | Location: SW |

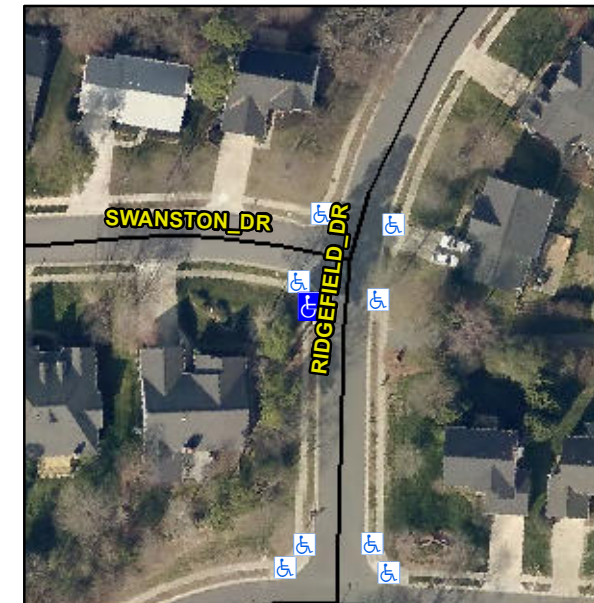
| ADA ID: CABD546B6021 | Ramp Type: PerpDiag | Initial Pass/Fail: Fail | Overall Compliance: No |
| | | Severity Score: 10 | |

**R304.5.1, R304.5.3**

| Compliance | Description | Data | Compliance | Description | Data |
|---|---|---|---|---|---|
| N/A | Ramp Length (in) | 49.5 | Yes | Ramp Slope (%) | 7.1 |
| No | Ramp Width (in) | 38.0 | No | Ramp XSlope (%) | 2.6 |

**Remove & Replace Curb Ramp With Two New Directional Ramps or Equivalent.**
