# Access Compliance Report

## Public Rights-of-Way

### (Curb Ramps)

Intersection ID: 10011741	Main Street: N_SHARON_AMITY_RD	Cross Street: N/A	Location: NE
ADA ID: CACAEC2FBEF3	Ramp Type: PerpDiag	Initial Pass/Fail: Fail	Overall Compliance: No
Severity Score: 22.5			
Codes/Mitigation Info/Possible Solution		Field Measurements/Component Compliance

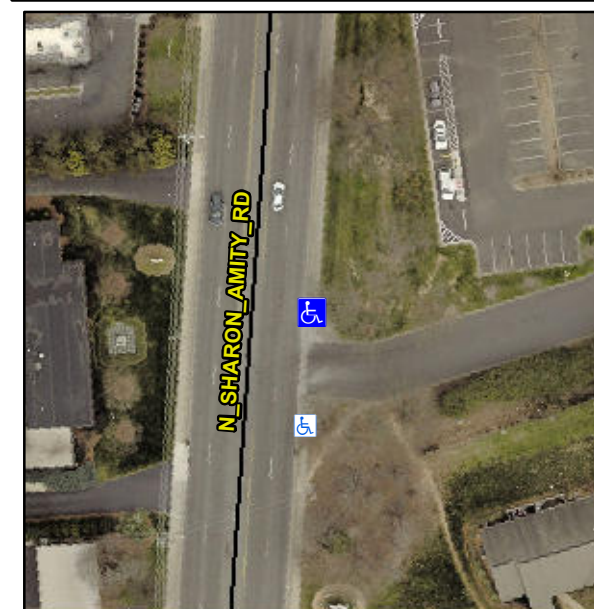
**Not Found, R304.5.1, R304.2.2, R304.5.3**

Compliance	Description	Data	Compliance	Description	Data
N/A	Ramp Length (in)	60.0	No	Ramp Slope (%)	10.8
No	Ramp Width (in)	44.0	No	Ramp XSlope (%)	3.2
N/A	Flare Type LT	N/A	N/A	Flare Type RT	N/A
N/A	Flare Slope LT (%)	N/A	N/A	Flare Slope RT (%)	N/A
N/A	Flare Traversable LT?	N/A	N/A	Flare Traversable RT?	N/A
N/A	Landing Length (in)	N/A	N/A	DWS Provided?	N/A
N/A	Landing Width (in)	N/A	N/A	DWS Contrast?	N/A
N/A	Landing Slope (%)	N/A	N/A	DWS Length (in)	N/A
N/A	Landing X Slope (%)	N/A	N/A	DWS Full Width?	N/A
N/A	Landing Curb? (Y/N)	N/A	N/A	DWS Offset (in)	N/A
N/A	Shared Landing?	N/A			
N/A	Gutter Ponding?	N/A	N/A	Gutter Slope (%)	N/A
N/A	Gutter Lip Ht (in)	N/A	N/A	Gutter X Slope (%)	N/A
N/A	Painted X Walk1?	No	N/A	Painted X Walk2?	No
	X Walk 1 Direction	To W		X Walk 2 Direction	To S
N/A	X Walk 1 Width (in)	N/A	N/A	X Walk 2 Width (in)	N/A
	X Walk 1 Slope (%)	2.5		X Walk 2 Slope (%)	1.0
	X Walk 1 X Slope (%)	0.4		X Walk 2 X Slope (%)	2.1

N/A	Ramp inside XWalk1?	N/A	N/A	Ramp inside XWalk2?	N/A
	Road Slope (%)	2.4	N/A	Clear Space?	N/A
	Road X Slope (%)	3.5	N/A	Clear Space to XWalk (in)	N/A
N/A	Any Obstructions?	N/A	N/A	Storm Grate/Utility Hazard?	N/A
	Obstruction Type			Storm Grate/Utility Type	
		N/A			N/A
			Yes	Surface Condition? (G/P)	Good

**Remove & Replace Curb Ramp With Two New Directional Ramps or Equivalent.**
