Access Compliance Report

Public Rights-of-Way

(Curb Ramps)

Intersection ID: 9099	Main Street: DEWOLFE_ST	Cross Street: JOYCETON_ST	Location: S
ADA ID: CAD8DFE0C274	Ramp Type: Perp	Initial Pass/Fail: Pass	Overall Compliance: No
		Severity Score: 0

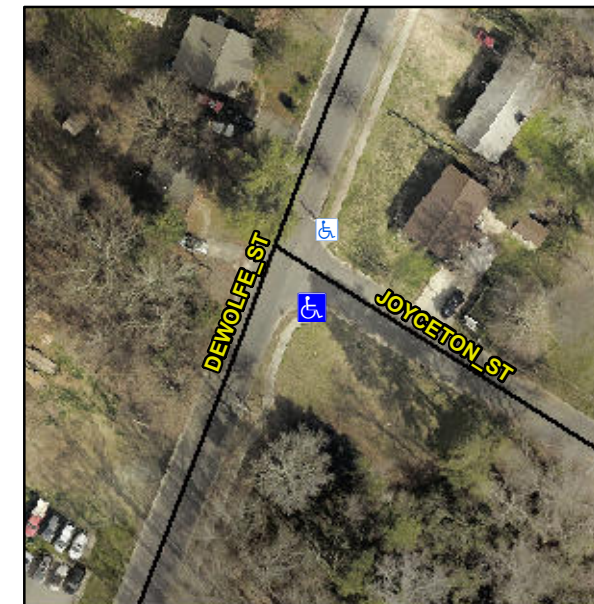
Not Found, R302.7

Compliance	Description	Data	Compliance	Description	Data
N/A	Ramp Length (in)	48.0	Yes	Ramp Slope (%)	6.0
Yes	Ramp Width (in)	48.0	Yes	Ramp XSlope (%)	1.0
N/A	Flare Type LT	Sloped	N/A	Flare Type RT	N/A
N/A	Flare Slope LT (%)	7.1	N/A	Flare Slope RT (%)	5.0
N/A	Flare Traversable LT?	No	N/A	Flare Traversable RT?	No
Yes	Landing Length (in)	60.0	Yes	DWS Provided?	Yes
Yes	Landing Width (in)	57.0	Yes	DWS Contrast?	Yes
Yes	Landing Slope (%)	1.9	Yes	DWS Length (in)	24.5
Yes	Landing X Slope (%)	1.7	Yes	DWS Full Width?	Yes
N/A	Landing Curb? (Y/N)	No	Yes	DWS Offset (in)	2.0
N/A	Shared Landing?	No			
No	Gutter Ponding?	Yes	Yes	Gutter Slope (%)	0.2
Yes	Gutter Lip Ht (in)	0.0	Yes	Gutter X Slope (%)	1.3
N/A	Painted X Walk1?	No	N/A	Painted X Walk2?	N/A
	X Walk 1 Direction	To NE		X Walk 2 Direction	N/A
N/A	X Walk 1 Width (in)	N/A	N/A	X Walk 2 Width (in)	N/A
	X Walk 1 Slope (%)	1.6		X Walk 2 Slope (%)	N/A
	X Walk 1 X Slope (%)	0.9		X Walk 2 X Slope (%)	N/A

N/A	Ramp inside XWalk1?	N/A	N/A	Ramp inside XWalk2?	N/A
	Road Slope (%)	N/A	N/A	Clear Space?	Yes
	Road X Slope (%)	N/A	N/A	Clear Space to XWalk (in)	N/A
Yes	Any Obstructions?	No	Yes	Storm Grate/Utility Hazard?	No
	Obstruction Type			Storm Grate/Utility Type	
		N/A			N/A
			Yes	Surface Condition? (G/P)	Good

Remove & Replace Entire Ramp.

Total Cost: \$ 1850.00
