Access Compliance Report

Public Rights-of-Way

(Curb Ramps)

| Intersection ID: 10037290 | Main Street: SARDIS_RD_NORTH | Cross Street: N/A | Location: NE |

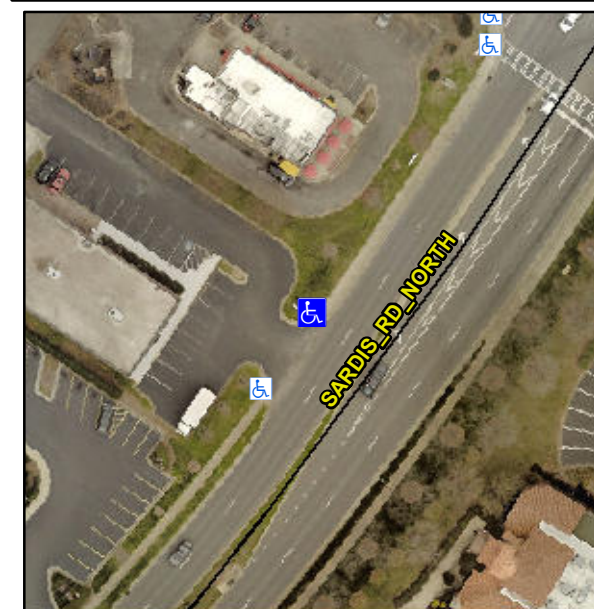
| ADA ID: CAE2010350EE | Ramp Type: Perp | Initial Pass/Fail: Fail | Overall Compliance: No |
| Severity Score: 31.25 | | | |

R304.5.1, R304.2.2, R304.5.3

| Compliance | Description | Data | Compliance | Description | Data |
|---|---|---|---|---|---|
| N/A | Ramp Length (in) | 71.0 | No | Ramp Slope (%) | 8.6 |
| No | Ramp Width (in) | 34.0 | No | Ramp XSlope (%) | 3.7 |

Remove & Replace Entire Ramp.
