Access Compliance Report

Public Rights-of-Way

| Intersection ID: 12545 | Main Street: S_POPLAR_ST | Cross Street: W_STONEWALL_ST | Location: S |
| ADA ID: CAF2A28615C6 | Ramp Type: PerpDiag | Initial Pass/Fail: Fail | Overall Compliance: No |

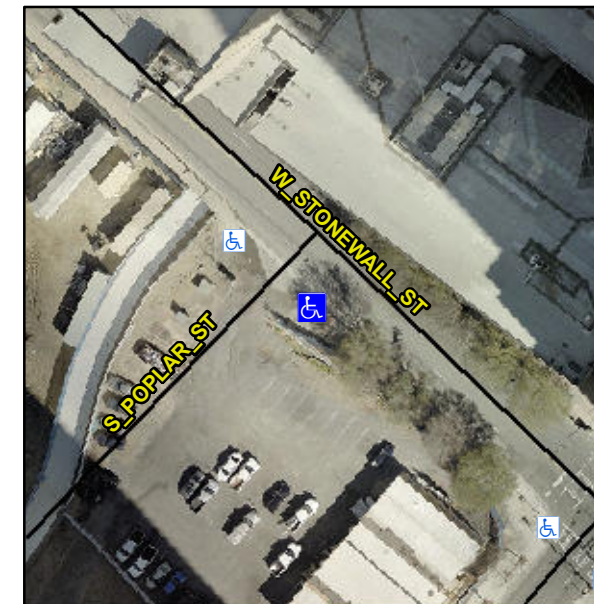
| | | Severity Score: 25 | |

R304.2.2, R304.5.3

| Compliance | Description | Data | Compliance | Description | Data |
|---|---|---|---|---|---|
| N/A | Ramp Length (in) | 37.0 | No | Ramp Slope (%) | 9.4 |
| Yes | Ramp Width (in) | 76.0 | No | Ramp XSlope (%) | 6.2 |

Remove & Replace Curb Ramp With Two New Directional Ramps or Equivalent.
