## Access Compliance Report Public Rights-of-Way (Curb Ramps)

Intersection ID: 48069Main Street:ELLIOTT\_STCross Street:FERRELL\_AVLocation:NEADA ID: CB040FEBA9E7Ramp Type:PerpInitial Pass/Fail:FailOverall Compliance:NoSeverity Score:8.75

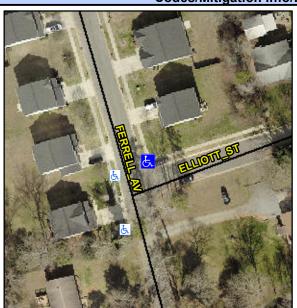
Comp	liance Description	Data	Comp	liance	Description	Data
N/A	Ramp Length (in)	50.0	Yes	Ramp	Slope (%)	7.4
No	Ramp Width (in)	46.5	Yes	Ramp	XSlope (%)	2.0
N/A	Flare Type LT	N/A	N/A	Flare	Type RT	N/A
N/A	Flare Slope LT (%)	N/A	N/A	Flare	Slope RT (%)	N/A
N/A	Flare Traversable LT?	N/A	N/A	Flare	Traversable RT?	N/A
N/A	Landing Length (in)	N/A	N/A	DWS	Provided?	N/A
N/A	Landing Width (in)	N/A	N/A	DWS	Contrast?	N/A
N/A	Landing Slope (%)	N/A	N/A	DWS	Length (in)	N/A
N/A	Landing X Slope (%)	N/A	N/A	DWS	Full Width?	N/A
N/A	Landing Curb? (Y/N)	N/A	N/A	DWS	Offset (in)	N/A
N/A	Shared Landing?	N/A				
N/A	Gutter Ponding?	N/A	N/A	Gutte	r Slope (%)	N/A
N/A	Gutter Lip Ht (in)	N/A	N/A	Gutte	r X Slope (%)	N/A
N/A	Painted X Walk1?	No	N/A	Paint	ed X Walk2?	N/A
	X Walk 1 Direction	To W		X Wa	lk 2 Direction	N/A
N/A	X Walk 1 Width (in)	N/A	N/A	X Wa	lk 2 Width (in)	N/A
	X Walk 1 Slope (%)	3.9		X Wa	lk 2 Slope (%)	N/A
	X Walk 1 X Slope (%)	1.9		X Wa	lk 2 X Slope (%)	N/A

N/A	Ramp inside XWalk1?	N/A	N/A	Ram	inside XWalk2?	N/A
	Road Slope (%)	N/A	N/A	Clear	Space?	N/A
	Road X Slope (%)	N/A	N/A	Clear	Space to XWalk (in)	N/A
N/A	Any Obstructions?	N/A	N/A	Storn	n Grate/Utility Hazard?	N/A
	Obstruction Type			Storn	n Grate/Utility Type	
		N/A				N/A
			Yes	Surfa	ce Condition? (G/P)	Good

Possible Solution	
Possible Solutions:	Co
Remove & Replace Entire Ramp.	
•	No
	N/A
	N/A
	N/A
	N/A
Surveyor Notes:	N/A
N/A	N/A
	N/A
	N/A
	N/A
PROW/ADA:	N/A
Not Found, R304.5.1	N/A
·	N/A
	N/A
	N/A
