# Access Compliance Report

## Public Rights-of-Way

### (Curb Ramps)

Intersection ID: 5333	Main Street: COMPATIBLE_WY	Cross Street: IBM_DR	Location:	N
ADA ID: CB07E873C6A0	Ramp Type: Perp	Initial Pass/Fail: Fail	Overall Compliance: No	Severity Score: 30

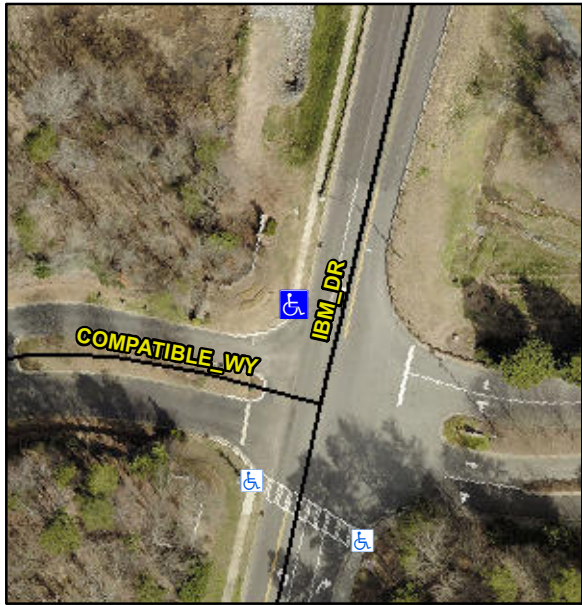
Possible Solutions:		Compliance	Description	Data	Compliance	Description	Data
	Remove & Replace Entire Ramp.		N/A	Ramp Length (in)	50.0	No	Ramp Slope (%)	8.6
			No	Ramp Width (in)	35.0	Yes	Ramp XSlope (%)	1.2
			N/A	Flare Type LT	N/A	N/A	Flare Type RT	N/A
			N/A	Flare Slope LT (%)	N/A	N/A	Flare Slope RT (%)	N/A
			N/A	Flare Traversable LT?	N/A	N/A	Flare Traversable RT?	N/A
			N/A	Landing Length (in)	N/A	N/A	DWS Provided?	N/A
			N/A	Landing Width (in)	N/A	N/A	DWS Contrast?	N/A
			N/A	Landing Slope (%)	N/A	N/A	DWS Length (in)	N/A
			N/A	Landing X Slope (%)	N/A	N/A	DWS Full Width?	N/A
<p>Surveyor Notes:</p> <p>N/A</p> <p>PROW/ADA:</p> <p>Not Found, R304.5.1, R304.2.2</p>			N/A	Landing Curb? (Y/N)	N/A	N/A	DWS Offset (in)	N/A
			N/A	Shared Landing?	N/A			
			N/A	Gutter Ponding?	Yes	N/A	Gutter Slope (%)	N/A
			N/A	Gutter Lip Ht (in)	N/A	N/A	Gutter X Slope (%)	N/A

N/A	Painted X Walk1?	No	N/A	Painted X Walk2?	N/A
				X Walk 1 Direction	To SW		X Walk 2 Direction	N/A
			N/A	X Walk 1 Width (in)	N/A	N/A	X Walk 2 Width (in)	N/A
				X Walk 1 Slope (%)	1.1		X Walk 2 Slope (%)	N/A
				X Walk 1 X Slope (%)	0.4		X Walk 2 X Slope (%)	N/A
			N/A	Ramp inside XWalk1?	N/A	N/A	Ramp inside XWalk2?	N/A
<p>Total Cost:</p> <p>\$ 1850.00</p>				Road Slope (%)	N/A	N/A	Clear Space?	N/A
				Road X Slope (%)	N/A	N/A	Clear Space to XWalk (in)	N/A
			N/A	Any Obstructions?	N/A	N/A	Storm Grate/Utility Hazard?	N/A
				Obstruction Type			Storm Grate/Utility Type	
					N/A			N/A
						Yes	Surface Condition? (G/P)	Good
