# Access Compliance Report

## Public Rights-of-Way

### (Curb Ramps)

Intersection ID: N/A	Main Street: REED_BV	Cross Street: N/A	Location: S
ADA ID: CB08DF5480B5	Ramp Type: Perp	Initial Pass/Fail: Fail	Overall Compliance: No
			Severity Score: 13.75

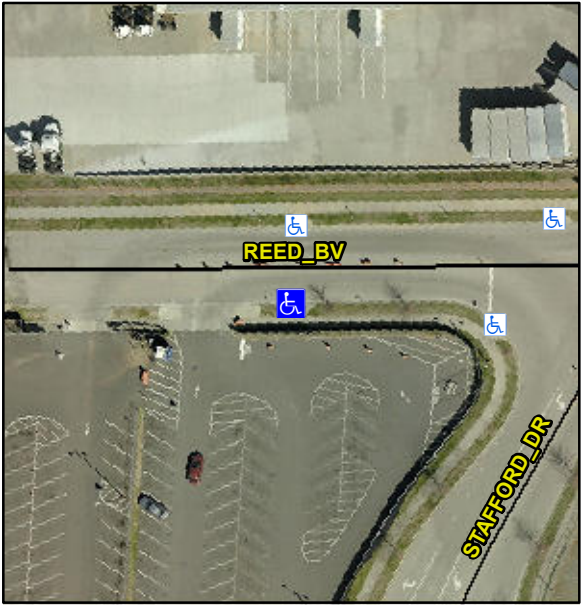
PROW/ADA:		N/A	Flare Type LT	N/A
	<b>Not Found, R304.2.2, R304.5.3</b>		N/A	Flare Slope LT (%)	N/A

Possible Solutions:		<b>Compliance</b>	<b>Description</b>	<b>Data</b>
	<b>Remove &amp; Replace Entire Ramp.</b>		<b>Compliance</b>	<b>Description</b>	<b>Data</b>

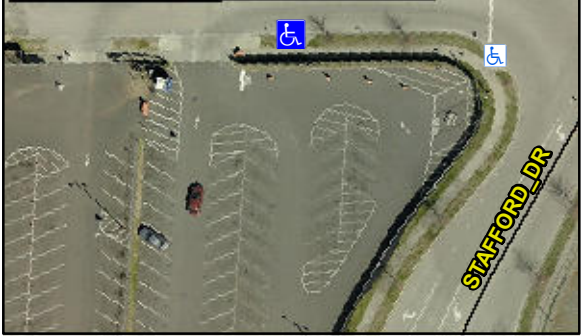
Surveyor Notes:		N/A	Ramp Length (in)	73.0
	N/A		Yes	Ramp Width (in)	48.0
