Access Compliance Report

Public Rights-of-Way

(Curb Ramps)

Intersection ID: 15036	Main Street: MAGNOLIA_AV	Cross Street: MCDONALD_AV	Location: SE
ADA ID: CB0E7B69856D	Ramp Type: Directional1	Initial Pass/Fail: Fail	Overall Compliance: No
		Severity Score: 25

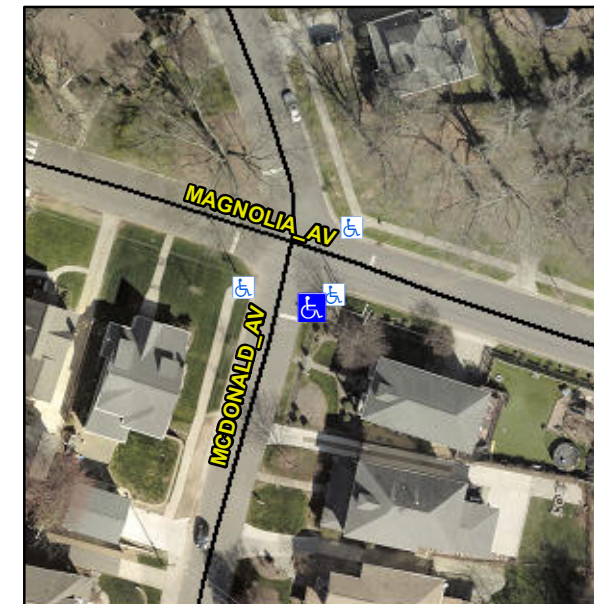
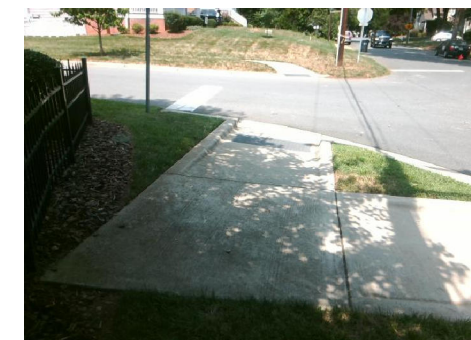
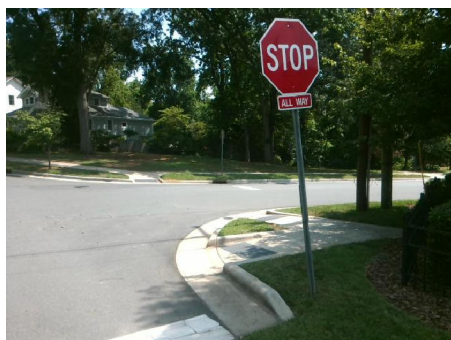
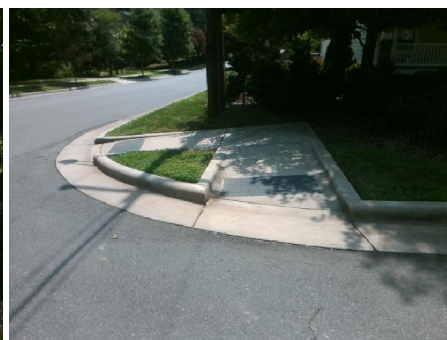
Compliance	Description	Data	Compliance	Description	Data
N/A	Ramp Length (in)	84.0	N/A	Grade Break?	N/A
Yes	Ramp Width (in)	57.0	N/A	Grade Break Slope (%)	0.0
Yes	Ramp Slope (%)	2.1	N/A	Grade Break XSlope (%)	0.0
No	Ramp XSlope (%)	7.4			
N/A	Flare Type LT	N/A	N/A	Flare Type RT	N/A
N/A	Flare Slope LT (%)	N/A	N/A	Flare Slope RT (%)	0.0
N/A	Flare Traversable LT?	N/A	N/A	Flare Traversable RT?	N/A
N/A	Landing Length (in)	0.0	N/A	DWS Provided?	N/A
N/A	Landing Width (in)	0.0	N/A	DWS Contrast?	N/A
N/A	Landing Slope (%)	0.0	N/A	DWS Length (in)	N/A
N/A	Landing X Slope (%)	0.0	N/A	DWS Full Width?	N/A
N/A	Landing Curb? (Y/N)	N/A	N/A	DWS Offset LT (in)	N/A
N/A	Shared Landing?	N/A	N/A	DWS Offset RT (in)	N/A
N/A	Gutter Ponding?	0.0	N/A	Gutter Slope (%)	N/A
N/A	Gutter Lip Ht (in)	0.0	N/A	Gutter X Slope (%)	N/A
N/A	Painted X Walk1?	No		Road Slope (%)	6.3
	X Walk 1 Direction	To W		Road X Slope (%)	5.4
	X Walk 1 Width (in)	N/A		Clear Space?	N/A

X Walk 1 Slope (%)	6.3	N/A	Clear Space to XWalk (in)	N/A
	X Walk 1 X Slope (%)	5.4	N/A	Storm Grate/Utility Hazard?	N/A
N/A	Ramp inside XWalk1?	N/A		Storm Grate/Utility Type	
N/A	Any Obstructions?	N/A			N/A
	Obstruction Type		Yes	Surface Condition? (G/P)	Good
			N/A	Curb Slope (%)	9.1

Remove & Replace Entire Ramp.

R304.5.3
