Access Compliance Report Public Rights-of-Way (Curb Ramps)

Intersection ID: 16342 Main Street: ALLISTER_DR Cross Street: E W T HARRIS BV Location: SE

ADA ID: CB21804730FF Ramp Type: PerpDiag Initial Pass/Fail: Fail Overall Compliance: No Severity Score: 8.75

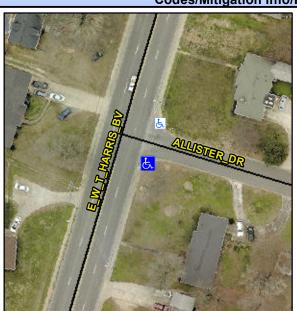
PROW/ADA:
Not Found, R304.5.1

| | Field Measure | ements/Co | ompo | nent Compliance | |
|---|---|---|---|---|---|
| No | Ramp Width (in) | 36.0 | Yes | Ramp XSlope (%) | 1.9 |

Remove & Replace Curb Ramp With
Two New Directional Ramps or
Equivalent.
