# Access Compliance Report

## Public Rights-of-Way

| Intersection ID: 17066 | Main Street: BRIARGATE_RD | Cross Street: MISSION_HILLS_RD | Location: NE |
| ADA ID: CB2309641F36 | Ramp Type: PerpDiag | Initial Pass/Fail: Fail | Overall Compliance: No |

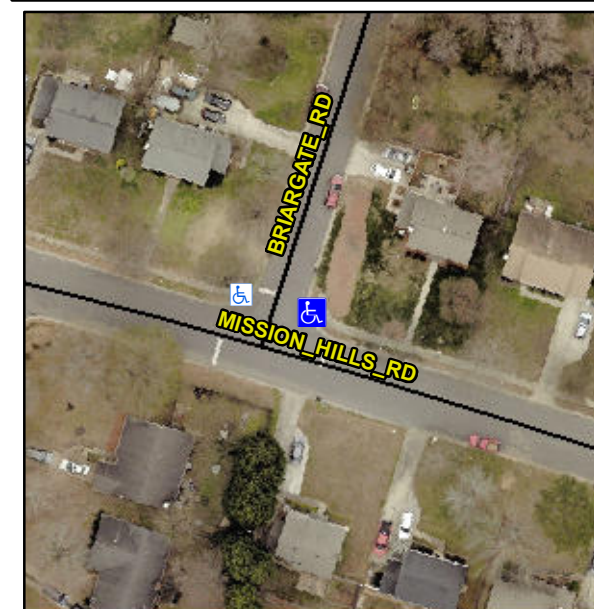
| Severity Score: 1.25 | | | |

**Not Found, R304.5.3**

| Compliance | Description | Data | Compliance | Description | Data |
|---|---|---|---|---|---|
| N/A | Ramp Length (in) | 44.0 | Yes | Ramp Slope (%) | 5.2 |
| Yes | Ramp Width (in) | 48.0 | No | Ramp XSlope (%) | 2.6 |

**Remove & Replace Curb Ramp With Two New Directional Ramps or Equivalent.**

Total Cost: \$ 3200.00
