Access Compliance Report

Public Rights-of-Way (Curb Ramps)

| Intersection ID: 20718 | Main Street: PROVIDENCE_RD | Cross Street: EAST_BARDEN_RD | Location: W |
| ADA ID: CB25CC46C600 | Ramp Type: PerpDiag | Initial Pass/Fail: Fail | Overall Compliance: No |

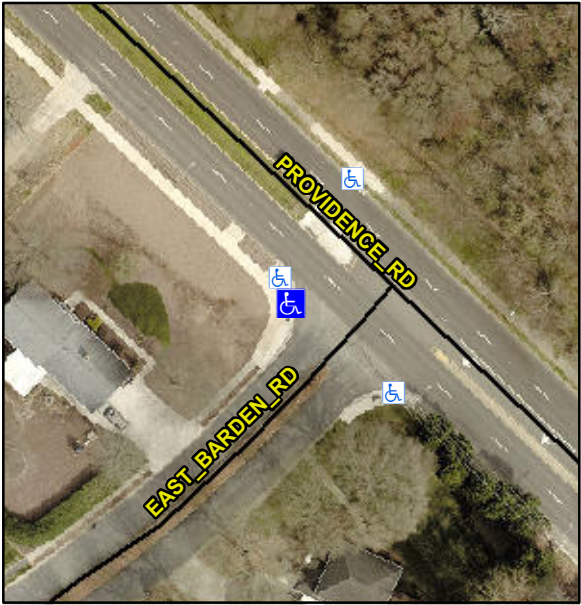
| | R304.2.2, R304.5.3 | | | | | | |
| Stop Condition-Street 2 | StopSign | N/A | Ramp Length (in) | 58.0 | No | Ramp Slope (%) | 8.6 |
| Street 2 Name | PROVIDENCE RD | Yes | Ramp Width (in) | 59.0 | No | Ramp XSlope (%) | 3.8 |

| | Remove & Replace Curb Ramp With Two New Directional Ramps or Equivalent. | | | | | | |
