Access Compliance Report Public Rights-of-Way (Curb Ramps)

Intersection ID: 17548 Main Street: ROSWELL AV **Cross Street: STERLING RD** Location: SE

ADA ID: CB2B75D125ED Ramp Type: PerpDiag Initial Pass/Fail: Fail **Overall Compliance: No** Severity Score: 21.25

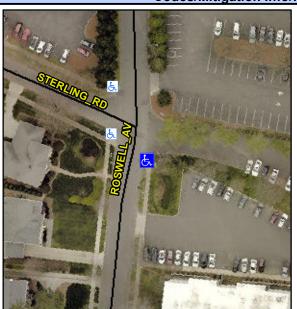
Field Measurements/Component Compilance						
Compliance Description		Data	Compliance Description		Data	
N/A	Ramp Length (in)	46.0	No	Ramp Slope (%)	9.6	
No	Ramp Width (in)	45.0	Yes	Ramp XSlope (%)	1.1	
N/A	Flare Type LT	N/A	N/A	Flare Type RT	N/A	
N/A	Flare Slope LT (%)	N/A	N/A	Flare Slope RT (%)	N/A	
N/A	Flare Traversable LT?	N/A	N/A	Flare Traversable RT?	N/A	
N/A	Landing Length (in)	N/A	N/A	DWS Provided?	N/A	
N/A	Landing Width (in)	N/A	N/A	DWS Contrast?	N/A	
N/A	Landing Slope (%)	N/A	N/A	DWS Length (in)	N/A	
N/A	Landing X Slope (%)	N/A	N/A	DWS Full Width?	N/A	
N/A	Landing Curb? (Y/N)	N/A	N/A	DWS Offset (in)	N/A	
N/A	Shared Landing?	N/A				
N/A	Gutter Ponding?	N/A	N/A	Gutter Slope (%)	N/A	
N/A	Gutter Lip Ht (in)	N/A	N/A	Gutter X Slope (%)	N/A	
N/A	Painted X Walk1?	No	N/A	Painted X Walk2?	No	
	X Walk 1 Direction	To N		X Walk 2 Direction	To NW	
N/A	X Walk 1 Width (in)	N/A	N/A	X Walk 2 Width (in)	N/A	
	X Walk 1 Slope (%)	0.6		X Walk 2 Slope (%)	3.3

X Walk 1 X Slope (%)	2.2		X Walk 2 X Slope (%)	0.3	
N/A	Ramp inside XWalk1?	N/A	N/A	Ramp inside XWalk2?	N/A	
	Road Slope (%)	2.4	N/A	Clear Space?	N/A	
	Road X Slope (%)	4.6	N/A	Clear Space to XWalk (in)	N/A	
N/A	Any Obstructions?	N/A	N/A	Storm Grate/Utility Hazard?	N/A	
	Obstruction Type			Storm Grate/Utility Type		
		N/A			N/A	
			Yes	Surface Condition? (G/P)	Good

Possible Solutions: Remove & Replace Curb Ramp With Two New Directional Ramps or Equivalent. Surveyor Notes: N/A PROW/ADA: Not Found, R304.5.1, R304.2.2
