Access Compliance Report

Public Rights-of-Way

(Curb Ramps)

Intersection ID: 27717	Main Street: HEADFORD_RD	Cross Street: LEINSTER_DR	Location: SE
ADA ID: CB2D65420A36	Ramp Type: BlendTrans1	Initial Pass/Fail: Fail	Overall Compliance: No
			Severity Score: 36.25

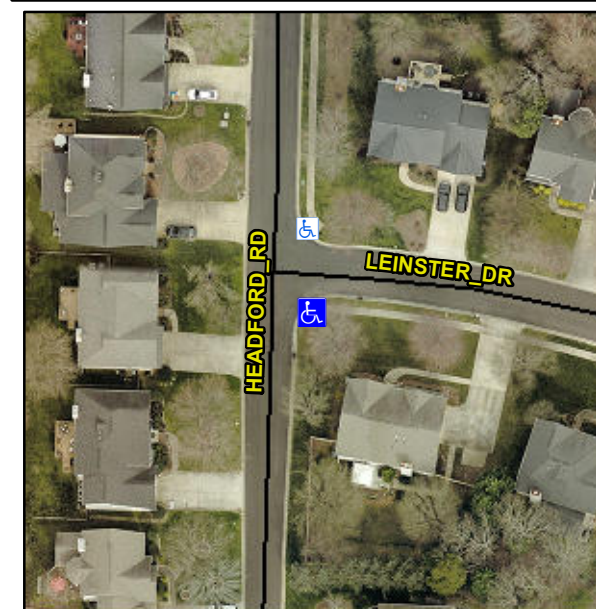
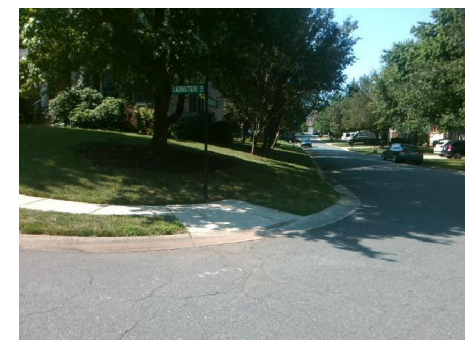
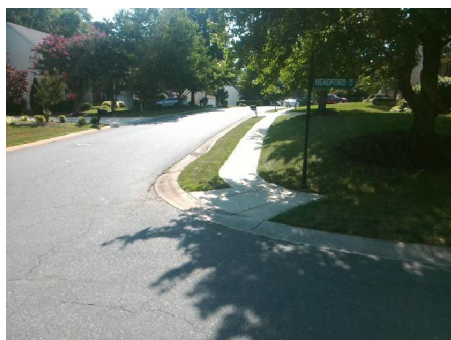
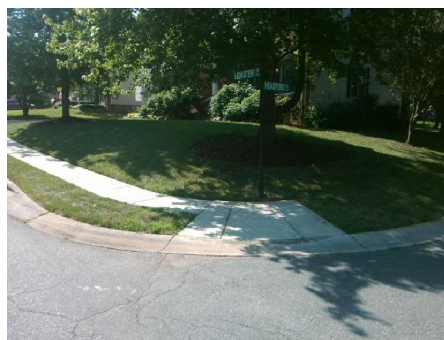
Not Found, R304.5.1, R304.5.3

Compliance	Description	Data	Compliance	Description	Data
N/A	Ramp Length (in)	93.0	Yes	BlendTrans Slope (%)	4.8
No	Ramp Width (in)	31.0	No	BlendTrans XSlope (%)	2.8
N/A	Flare Type LT	N/A	N/A	Flare Type RT	N/A
N/A	Flare Slope LT (%)	N/A	N/A	Flare Slope RT (%)	N/A
N/A	Flare Traversable LT?	N/A	N/A	Flare Traversable RT?	N/A
N/A	Landing Length (in)	N/A	N/A	DWS Provided?	N/A
N/A	Landing Width (in)	N/A	N/A	DWS Contrast?	N/A
N/A	Landing Slope (%)	N/A	N/A	DWS Length (in)	N/A
N/A	Landing X Slope (%)	N/A	N/A	DWS Full Width?	N/A
N/A	Landing Curb? (Y/N)	N/A	N/A	DWS Offset (in)	N/A
N/A	Shared Landing?	N/A			
N/A	Gutter Ponding?	N/A	N/A	Gutter Slope (%)	N/A
N/A	Gutter Lip Ht (in)	N/A	N/A	Gutter X Slope (%)	N/A
N/A	Painted X Walk1?	No	N/A	Painted X Walk2?	No
	X Walk 1 Direction	To N		X Walk 2 Direction	To W
	X Walk 1 Width (in)	N/A		X Walk 2 Width (in)	N/A
	X Walk 1 Slope (%)	0.6		X Walk 2 Slope (%)	1.0
	X Walk 1 X Slope (%)	0.9		X Walk 2 X Slope (%)	2.1

N/A	Ramp inside XWalk1?	N/A	N/A	Ramp inside XWalk2?	N/A
	Road Slope (%)	0.5		Clear Space?	N/A
	Road X Slope (%)	2.0	N/A	Clear Space to XWalk (in)	N/A
N/A	Any Obstructions?	N/A	N/A	Storm Grate/Utility Hazard?	N/A
	Obstruction Type			Storm Grate/Utility Type	
		N/A			N/A
			Yes	Surface Condition? (G/P)	Good
			No	Curb Slope (%)	16.1

Remove & Replace Curb Ramp With Two New Directional Ramps or Equivalent.
