Access Compliance Report

Public Rights-of-Way

(Curb Ramps)

Intersection ID: 3525	Main Street: BRIDLE_RIDGE_LN	Cross Street: STEED_CT	Location:	S
ADA ID: CB46CE5F5857	Ramp Type: Perp	Initial Pass/Fail: Fail	Overall Compliance: No	Severity Score: 10

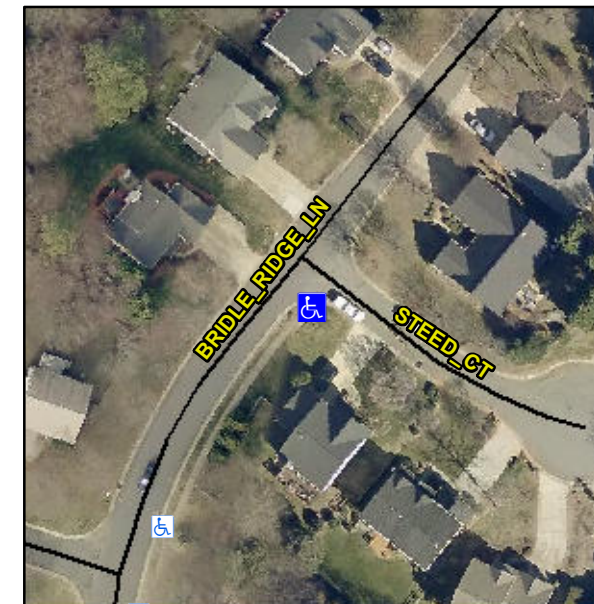
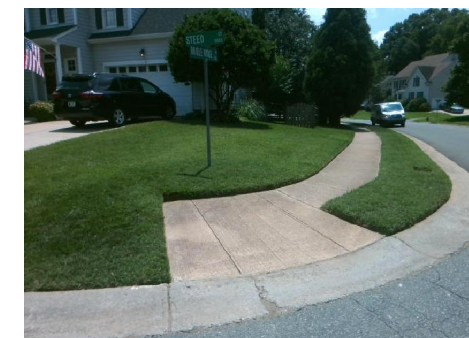
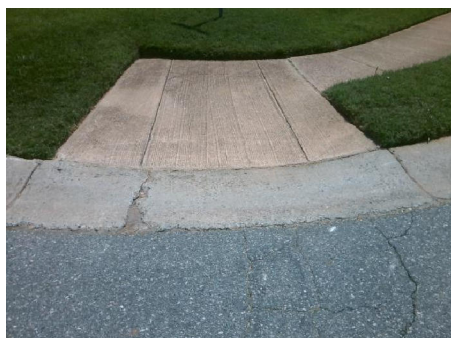
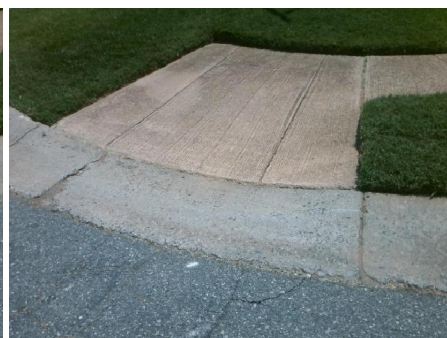
Not Found, R304.5.1, R304.5.3

Compliance	Description	Data	Compliance	Description	Data
N/A	Ramp Length (in)	49.0	Yes	Ramp Slope (%)	8.1
No	Ramp Width (in)	45.0	No	Ramp XSlope (%)	3.2
N/A	Flare Type LT	N/A	N/A	Flare Type RT	N/A
N/A	Flare Slope LT (%)	N/A	N/A	Flare Slope RT (%)	N/A
N/A	Flare Traversable LT?	N/A	N/A	Flare Traversable RT?	N/A
N/A	Landing Length (in)	N/A	N/A	DWS Provided?	N/A
N/A	Landing Width (in)	N/A	N/A	DWS Contrast?	N/A
N/A	Landing Slope (%)	N/A	N/A	DWS Length (in)	N/A
N/A	Landing X Slope (%)	N/A	N/A	DWS Full Width?	N/A
N/A	Landing Curb? (Y/N)	N/A	N/A	DWS Offset (in)	N/A
N/A	Shared Landing?	N/A			
N/A	Gutter Ponding?	N/A	N/A	Gutter Slope (%)	N/A
N/A	Gutter Lip Ht (in)	N/A	N/A	Gutter X Slope (%)	N/A
N/A	Painted X Walk1?	No	N/A	Painted X Walk2?	N/A
	X Walk 1 Direction	To NE		X Walk 2 Direction	N/A
N/A	X Walk 1 Width (in)	N/A	N/A	X Walk 2 Width (in)	N/A
	X Walk 1 Slope (%)	1.4		X Walk 2 Slope (%)	N/A
	X Walk 1 X Slope (%)	2.3		X Walk 2 X Slope (%)	N/A

Remove & Replace Entire Ramp.
