# Access Compliance Report

## Public Rights-of-Way

### (Curb Ramps)

Intersection ID: 5858	Main Street: CARMENET_LN	Cross Street: LONG_PAW_LN	Location: NW
ADA ID: CB4733D950C3	Ramp Type: PerpDiag	Initial Pass/Fail: Fail	Overall Compliance: No
		Severity Score: 22.5

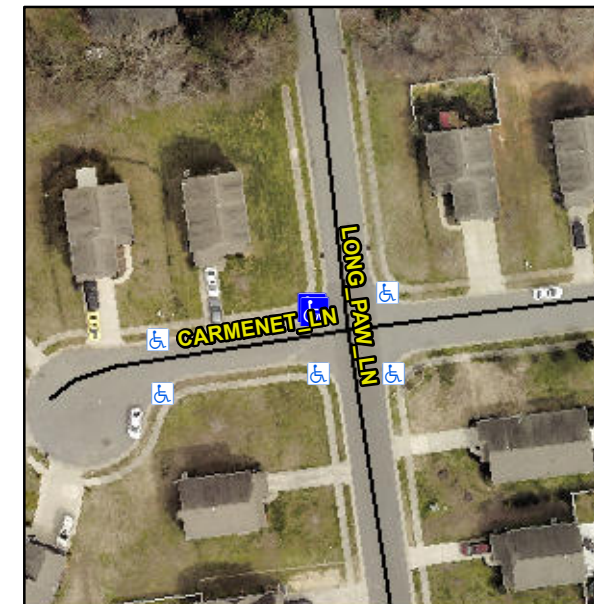
Compliance	Description	Data	Compliance	Description	Data
N/A	Ramp Length (in)	48.0	No	Ramp Slope (%)	11.3
No	Ramp Width (in)	41.0	No	Ramp XSlope (%)	3.0
N/A	Flare Type LT	N/A	N/A	Flare Type RT	N/A
N/A	Flare Slope LT (%)	N/A	N/A	Flare Slope RT (%)	N/A
N/A	Flare Traversable LT?	N/A	N/A	Flare Traversable RT?	N/A
N/A	Landing Length (in)	N/A	N/A	DWS Provided?	N/A
N/A	Landing Width (in)	N/A	N/A	DWS Contrast?	N/A
N/A	Landing Slope (%)	N/A	N/A	DWS Length (in)	N/A
N/A	Landing X Slope (%)	N/A	N/A	DWS Full Width?	N/A
N/A	Landing Curb? (Y/N)	N/A	N/A	DWS Offset (in)	N/A
N/A	Shared Landing?	N/A			
N/A	Gutter Ponding?	N/A	N/A	Gutter Slope (%)	N/A
N/A	Gutter Lip Ht (in)	N/A	N/A	Gutter X Slope (%)	N/A
N/A	Painted X Walk1?	No	N/A	Painted X Walk2?	No
	X Walk 1 Direction	To S		X Walk 2 Direction	To E
N/A	X Walk 1 Width (in)	N/A	N/A	X Walk 2 Width (in)	N/A
	X Walk 1 Slope (%)	0.6		X Walk 2 Slope (%)	4.6
	X Walk 1 X Slope (%)	1.2		X Walk 2 X Slope (%)	3.4

N/A	Ramp inside XWalk1?	N/A	N/A	Ramp inside XWalk2?	N/A
	Road Slope (%)	3.0	N/A	Clear Space?	N/A
	Road X Slope (%)	0.4	N/A	Clear Space to XWalk (in)	N/A
N/A	Any Obstructions?	N/A	N/A	Storm Grate/Utility Hazard?	N/A
	Obstruction Type			Storm Grate/Utility Type	
		N/A			N/A
			Yes	Surface Condition? (G/P)	Good

**Remove & Replace Curb Ramp With Two New Directional Ramps or Equivalent.**

**Not Found, R304.5.1, R304.2.2, R304.5.3**
