Access Compliance Report Public Rights-of-Way (Curb Ramps)

Intersection ID: 28322Main Street:ARDREY_KELL_RDCross Street:BEAU_RILEY_RDLocation:NWADA ID: CB509CB3851ERamp Type:MedianPerpInitial Pass/Fail:FailOverall Compliance:NoSeverity Score:25

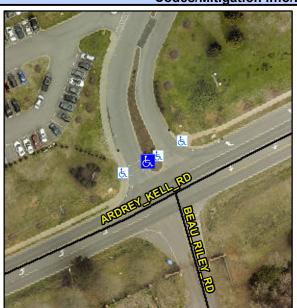
N/A	Ramp Length (in)	60.0	No	Ramp Slope (%)	14.5
Yes	Ramp Width (in)	58.0	Yes	Ramp XSlope (%)	2.0
N/A	Flare Type LT	N/A	N/A	Flare Type RT	N/A
N/A	Flare Slope LT (%)	N/A	N/A	Flare Slope RT (%)	N/A
N/A	Flare Traversable LT?	N/A	N/A	Flare Traversable RT?	N/A
N/A	Landing Length (in)	N/A	N/A	DWS Provided?	N/A
N/A	Landing Width (in)	N/A	N/A	DWS Contrast?	N/A
N/A	Landing Slope (%)	N/A	N/A	DWS Length (in)	N/A
N/A	Landing X Slope (%)	N/A	N/A	DWS Full Width?	N/A
N/A	Landing Curb? (Y/N)	N/A	N/A	DWS Offset (in)	N/A
N/A	Shared Landing?	N/A			
N/A	Gutter Ponding?	N/A	N/A	Gutter Slope (%)	N/A
N/A	Gutter Lip Ht (in)	N/A	N/A	Gutter X Slope (%)	N/A
N/A	Painted X Walk1?	Yes	N/A	Painted X Walk2?	N/A
	X Walk 1 Direction	To W		X Walk 2 Direction	N/A
N/A	X Walk 1 Width (in)	110.0	N/A	X Walk 2 Width (in)	N/A
	X Walk 1 Slope (%)	1.4		X Walk 2 Slope (%)	N/A
	X Walk 1 X Slope (%)	2.8		X Walk 2 X Slope (%)	N/A
N/A	Ramp inside XWalk1?	Yes	N/A	Ramp inside XWalk2?	N/A

Remove & Replace Entire Ramp.

Total Cost: \$ 1650.00
