Access Compliance Report

Public Rights-of-Way

(Curb Ramps)

| Intersection ID: 47457 | Main Street: STEELE_CREEK_RD | Cross Street: WINGED_TEAL_RD | Location: SW |

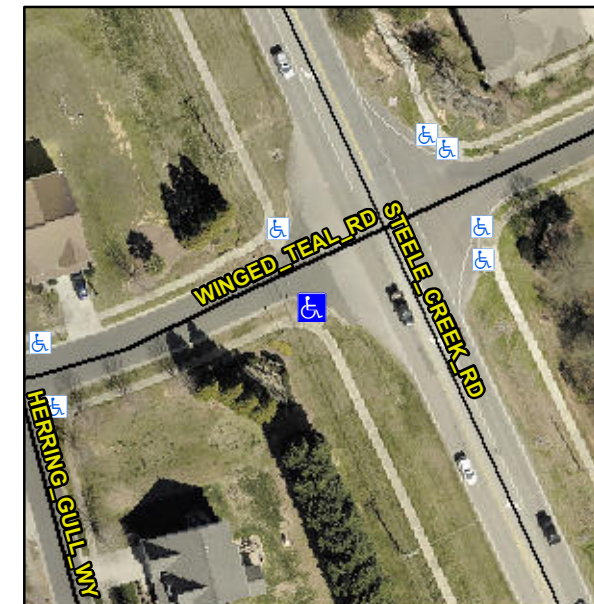
| ADA ID: CB69B6B0E399 | Ramp Type: PerpDiag | Initial Pass/Fail: Fail | Overall Compliance: No |
| | | Severity Score: 8.75 | |

Not Found, R304.5.1

| Compliance | Description | Data | Compliance | Description | Data |
|---|---|---|---|---|---|
| No | Ramp Width (in) | 44.0 | Yes | Ramp XSlope (%) | 1.0 |

Remove & Replace Curb Ramp With Two New Directional Ramps or Equivalent.
