Access Compliance Report

Public Rights-of-Way

(Curb Ramps)

Intersection ID: 26468	Main Street: BEVINGTON_PL	Cross Street: REA_RD	Location: SE
ADA ID: CB70CEE9C27F	Ramp Type: Perp	Initial Pass/Fail: Fail	Overall Compliance: No
Codes/Mitigation Info/Possible Solution		Field Measurements/Component Compliance	
Severity Score: 13.75

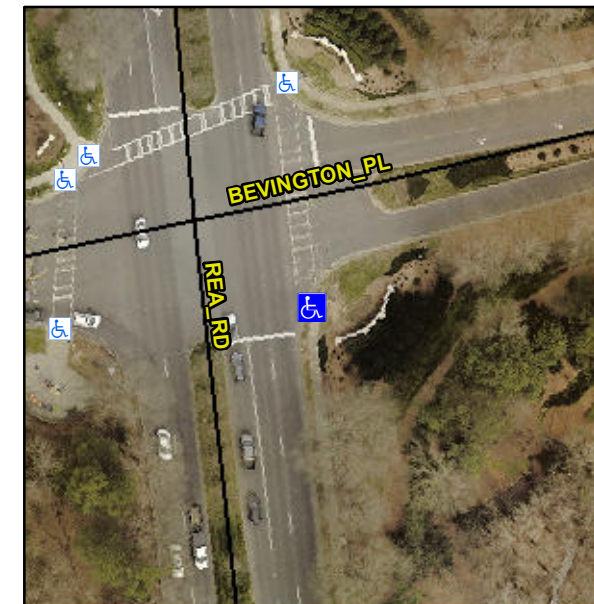
Compliance	Description	Data	Compliance	Description	Data
N/A	Ramp Length (in)	106.0	No	Ramp Slope (%)	8.8
Yes	Ramp Width (in)	48.0	Yes	Ramp XSlope (%)	2.3
N/A	Flare Type LT	N/A	N/A	Flare Type RT	N/A
N/A	Flare Slope LT (%)	N/A	N/A	Flare Slope RT (%)	N/A
N/A	Flare Traversable LT?	N/A	N/A	Flare Traversable RT?	N/A
N/A	Landing Length (in)	N/A	N/A	DWS Provided?	N/A
N/A	Landing Width (in)	N/A	N/A	DWS Contrast?	N/A
N/A	Landing Slope (%)	N/A	N/A	DWS Length (in)	N/A
N/A	Landing X Slope (%)	N/A	N/A	DWS Full Width?	N/A
N/A	Landing Curb? (Y/N)	N/A	N/A	DWS Offset (in)	N/A
N/A	Shared Landing?	N/A			
N/A	Gutter Ponding?	N/A	N/A	Gutter Slope (%)	N/A
N/A	Gutter Lip Ht (in)	N/A	N/A	Gutter X Slope (%)	N/A
N/A	Painted X Walk1?	Yes	N/A	Painted X Walk2?	N/A
	X Walk 1 Direction	To N		X Walk 2 Direction	N/A
N/A	X Walk 1 Width (in)	126.5	N/A	X Walk 2 Width (in)	N/A
	X Walk 1 Slope (%)	5.2		X Walk 2 Slope (%)	N/A
	X Walk 1 X Slope (%)	3.5		X Walk 2 X Slope (%)	N/A

N/A	Ramp inside XWalk1?	Yes	N/A	Ramp inside XWalk2?	N/A
	Road Slope (%)	N/A	N/A	Clear Space?	N/A
	Road X Slope (%)	N/A	N/A	Clear Space to XWalk (in)	N/A
N/A	Any Obstructions?	N/A	N/A	Storm Grate/Utility Hazard?	N/A
	Obstruction Type			Storm Grate/Utility Type	
		N/A			N/A
		Yes		Surface Condition? (G/P)	Good

Possible Solutions:

Remove & Replace Entire Ramp.

R304.2.2

Total Cost:

\$ 1850.00
