Access Compliance Report

Public Rights-of-Way

(Curb Ramps)

Intersection ID: 12577	Main Street: SEIGLE_AV	Cross Street: GREEN_TRAIL_LN	Location:	N
ADA ID: CB74AAC3C1C3	Ramp Type: Directional1	Initial Pass/Fail: Pass	Overall Compliance: No	Severity Score: 0
Codes/Mitigation Info/Possible Solution		Field Measurements/Component Compliance

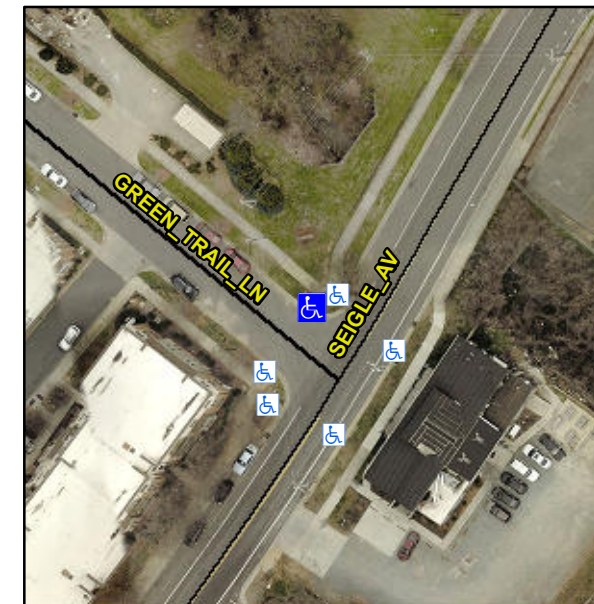
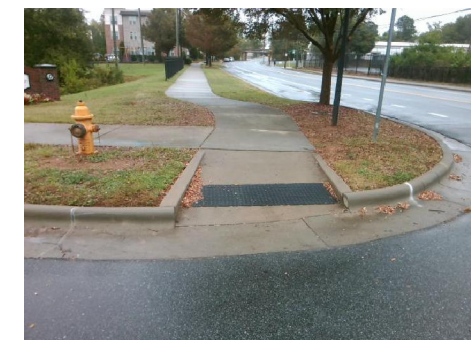
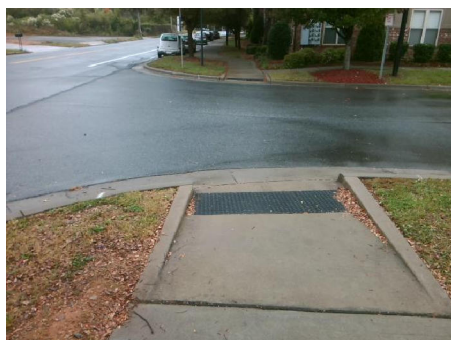
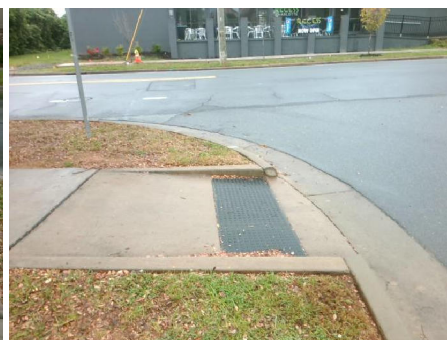
Not Found, R304.2.2-Perp, R304.3.2-Para, R304.5.3, R305.2

Compliance	Description	Data	Compliance	Description	Data
N/A	Ramp Length (in)	83.0	Yes	Grade Break?	Yes
Yes	Ramp Width (in)	69.0	No	Grade Break Slope (%)	5.4
Yes	Ramp Slope (%)	5.7	Yes	Grade Break XSlope (%)	0.1
Yes	Ramp XSlope (%)	0.8			
Yes	Flare Type LT	N/A	Yes	Flare Type RT	N/A
N/A	Flare Slope LT (%)	N/A	N/A	Flare Slope RT (%)	N/A
N/A	Flare Traversable LT?	No	N/A	Flare Traversable RT?	No
Yes	Landing Length (in)	68.5	Yes	DWS Provided?	Yes
Yes	Landing Width (in)	77.0	Yes	DWS Contrast?	Yes
No	Landing Slope (%)	2.3	Yes	DWS Length (in)	25.0
No	Landing X Slope (%)	3.4	Yes	DWS Full Width?	Yes
N/A	Landing Curb? (Y/N)	N/A	Yes	DWS Offset LT (in)	16.0
N/A	Shared Landing?	No	No	DWS Offset RT (in)	8.0
Yes	Gutter Ponding?	No	Yes	Gutter Slope (%)	0.7
Yes	Gutter Lip Ht (in)	0.0	Yes	Gutter X Slope (%)	1.6
N/A	Painted X Walk1?	No		Road Slope (%)	1.4
	X Walk 1 Direction	To SW		Road X Slope (%)	2.1
	X Walk 1 Width (in)	N/A		Clear Space?	Yes

X Walk 1 Slope (%)	1.4	N/A	Clear Space to XWalk (in)	N/A
	X Walk 1 X Slope (%)	2.1	Yes	Storm Grate/Utility Hazard?	No
N/A	Ramp inside XWalk1?	N/A		Storm Grate/Utility Type	
Yes	Any Obstructions?	No			N/A
	Obstruction Type		Yes	Surface Condition? (G/P)	Good
			N/A	Curb Slope (%)	9.2

Remove & Replace Entire Ramp.
