Access Compliance Report

Public Rights-of-Way

(Curb Ramps)

Intersection ID: 8922	Main Street: BARRINGTON_DR	Cross Street: BRIDLEWOOD_LN	Location: S
ADA ID: CB83B3C2DED3	Ramp Type: Perp	Initial Pass/Fail: Fail	Overall Compliance: No
Severity Score: 25			
Codes/Mitigation Info/Possible Solution		Field Measurements/Component Compliance

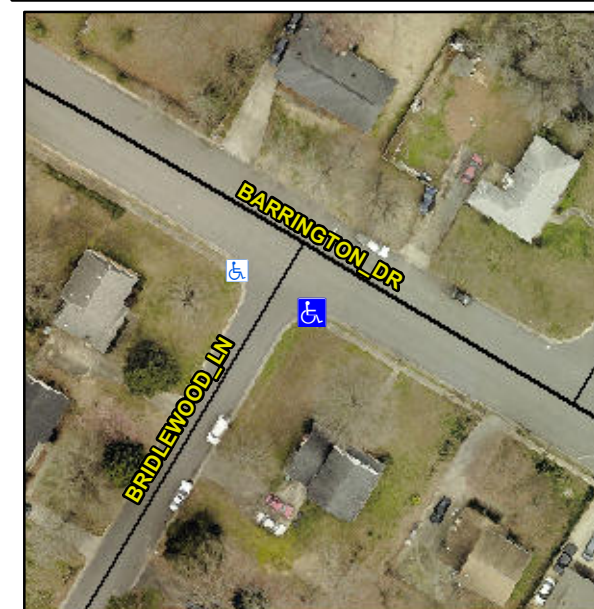
Not Found, R304.5.3

Compliance	Description	Data	Compliance	Description	Data
N/A	Ramp Length (in)	24.0	Yes	Ramp Slope (%)	8.1
Yes	Ramp Width (in)	48.0	No	Ramp XSlope (%)	7.8
N/A	Flare Type LT	N/A	N/A	Flare Type RT	N/A
N/A	Flare Slope LT (%)	N/A	N/A	Flare Slope RT (%)	N/A
N/A	Flare Traversable LT?	N/A	N/A	Flare Traversable RT?	N/A
N/A	Landing Length (in)	N/A	N/A	DWS Provided?	N/A
N/A	Landing Width (in)	N/A	N/A	DWS Contrast?	N/A
N/A	Landing Slope (%)	N/A	N/A	DWS Length (in)	N/A
N/A	Landing X Slope (%)	N/A	N/A	DWS Full Width?	N/A
N/A	Landing Curb? (Y/N)	N/A	N/A	DWS Offset (in)	N/A
N/A	Shared Landing?	N/A			
N/A	Gutter Ponding?	N/A	N/A	Gutter Slope (%)	N/A
N/A	Gutter Lip Ht (in)	0.5	N/A	Gutter X Slope (%)	N/A
N/A	Painted X Walk1?	No	N/A	Painted X Walk2?	N/A
	X Walk 1 Direction	To NW		X Walk 2 Direction	N/A
N/A	X Walk 1 Width (in)	N/A	N/A	X Walk 2 Width (in)	N/A
	X Walk 1 Slope (%)	4.8		X Walk 2 Slope (%)	N/A
	X Walk 1 X Slope (%)	1.6		X Walk 2 X Slope (%)	N/A

N/A	Ramp inside XWalk1?	N/A	N/A	Ramp inside XWalk2?	N/A
	Road Slope (%)	N/A	N/A	Clear Space?	N/A
	Road X Slope (%)	N/A	N/A	Clear Space to XWalk (in)	N/A
N/A	Any Obstructions?	N/A	N/A	Storm Grate/Utility Hazard?	N/A
	Obstruction Type			Storm Grate/Utility Type	
		N/A			N/A
		Yes		Surface Condition? (G/P)	Good

Possible Solutions:

Remove & Replace Entire Ramp.

Total Cost: \$ 1850.00
