# Access Compliance Report

## Public Rights-of-Way

### (Curb Ramps)

Intersection ID: 45177	Main Street: ELDON_DR	Cross Street: GARLAND_CT	Location: SE
ADA ID: CBA1773FF61B	Ramp Type: PerpDiag	Initial Pass/Fail: Fail	Overall Compliance: No
Codes/Mitigation Info/Possible Solution			Severity Score: 25
			Field Measurements/Component Compliance

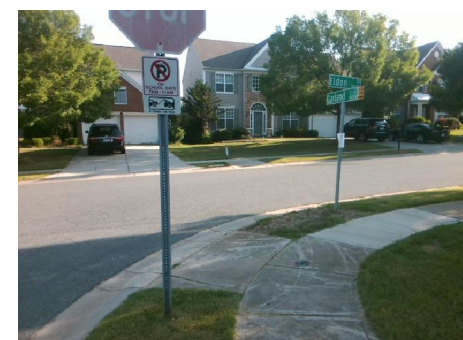
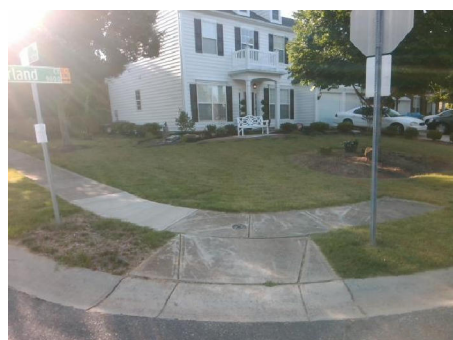
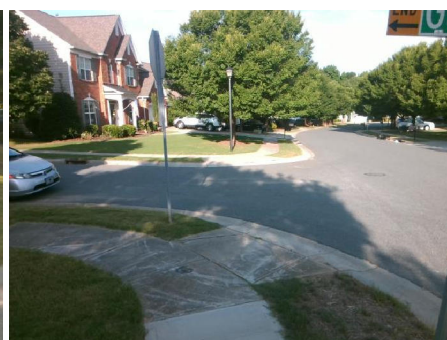
**Not Found, R304.2.2, R304.5.3**

Compliance	Description	Data	Compliance	Description	Data
N/A	Ramp Length (in)	68.0	No	Ramp Slope (%)	9.1
Yes	Ramp Width (in)	51.0	No	Ramp XSlope (%)	6.1
N/A	Flare Type LT	N/A	N/A	Flare Type RT	N/A
N/A	Flare Slope LT (%)	N/A	N/A	Flare Slope RT (%)	N/A
N/A	Flare Traversable LT?	N/A	N/A	Flare Traversable RT?	N/A
N/A	Landing Length (in)	N/A	N/A	DWS Provided?	N/A
N/A	Landing Width (in)	N/A	N/A	DWS Contrast?	N/A
N/A	Landing Slope (%)	N/A	N/A	DWS Length (in)	N/A
N/A	Landing X Slope (%)	N/A	N/A	DWS Full Width?	N/A
N/A	Landing Curb? (Y/N)	N/A	N/A	DWS Offset (in)	N/A
N/A	Shared Landing?	N/A			
N/A	Gutter Ponding?	N/A	N/A	Gutter Slope (%)	N/A
N/A	Gutter Lip Ht (in)	N/A	N/A	Gutter X Slope (%)	N/A
N/A	Painted X Walk1?	No	N/A	Painted X Walk2?	No
	X Walk 1 Direction	To NE		X Walk 2 Direction	To W
N/A	X Walk 1 Width (in)	N/A	N/A	X Walk 2 Width (in)	N/A
	X Walk 1 Slope (%)	2.1		X Walk 2 Slope (%)	3.0
	X Walk 1 X Slope (%)	2.3		X Walk 2 X Slope (%)	0.6

N/A	Ramp inside XWalk1?	N/A	N/A	Ramp inside XWalk2?	N/A
	Road Slope (%)	2.3	N/A	Clear Space?	N/A
	Road X Slope (%)	3.7	N/A	Clear Space to XWalk (in)	N/A
N/A	Any Obstructions?	N/A	N/A	Storm Grate/Utility Hazard?	N/A
	Obstruction Type			Storm Grate/Utility Type	
		N/A			N/A
			Yes	Surface Condition? (G/P)	Good

**Remove & Replace Curb Ramp With Two New Directional Ramps or Equivalent.**
