Access Compliance Report Public Rights-of-Way (Curb Ramps)

Intersection ID: 14442 Main Street: N_SHARON_AMITY_RD Cross Street: CENTRAL_AV Location: SE **Overall Compliance: No ADA ID: CBA588D8799C** Ramp Type: Perp Initial Pass/Fail: Fail **Severity Score:** 25

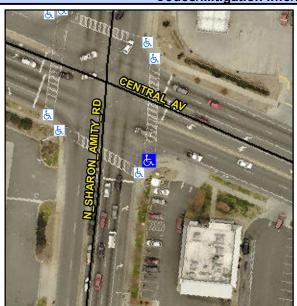
Field Measurements/Component Compliance							
Compl	iance Description	Data	Comp	liance Description	Data		
N/A	Ramp Length (in)	58.5	No	Ramp Slope (%)	9.6		
Yes	Ramp Width (in)	48.0	No	Ramp XSlope (%)	5.3		
N/A	Flare Type LT	N/A	N/A	Flare Type RT	N/A		
N/A	Flare Slope LT (%)	N/A	N/A	Flare Slope RT (%)	N/A		
N/A	Flare Traversable LT?	N/A	N/A	Flare Traversable RT?	N/A		
N/A	Landing Length (in)	N/A	N/A	DWS Provided?	N/A		
N/A	Landing Width (in)	N/A	N/A	DWS Contrast?	N/A		
N/A	Landing Slope (%)	N/A	N/A	DWS Length (in)	N/A		
N/A	Landing X Slope (%)	N/A	N/A	DWS Full Width?	N/A		
N/A	Landing Curb? (Y/N)	N/A	N/A	DWS Offset (in)	N/A		
N/A	Shared Landing?	N/A					
N/A	Gutter Ponding?	N/A	N/A	Gutter Slope (%)	N/A		
N/A	Gutter Lip Ht (in)	N/A	N/A	Gutter X Slope (%)	N/A		
N/A	Painted X Walk1?	Yes	N/A	Painted X Walk2?	N/A		
	X Walk 1 Direction	To N		X Walk 2 Direction	N/A		
N/A	X Walk 1 Width (in)	112.0	N/A	X Walk 2 Width (in)	N/A

X Walk 1 Slope (%)	3.1		X Walk 2 Slope (%)	N/A		
	X Walk 1 X Slope (%)	4.3		X Walk 2 X Slope (%)	N/A		
N/A	Ramp inside XWalk1?	Yes	N/A	Ramp inside XWalk2?	N/A		
	Road Slope (%)	N/A	N/A	Clear Space?	N/A		
	Road X Slope (%)	N/A	N/A	Clear Space to XWalk (in)	N/A		
N/A	Any Obstructions?	N/A	N/A	Storm Grate/Utility Hazard?	N/A		
	Obstruction Type			Storm Grate/Utility Type			
		N/A			N/A		
			Yes	Surface Condition? (G/P)	Good

Possible Solutions:				
Remove & Replace Entire Ramp.				
	ĺ			
Surveyor Notes:	ı			
N/A	ı			
	ı			
PROW/ADA:				
Not Found, R304.2.2, R304.5.3	ı			
, , , , , , , , , , , , , , , , , , , ,	ı			
	ı			
	•
