Access Compliance Report

Public Rights-of-Way

(Curb Ramps)

Intersection ID: 44072	Main Street: SEDGEMOOR_LN	Cross Street: OVERSTONE_CT	Location: NE
ADA ID: CBAF5DC8BE98	Ramp Type: BlendTrans1	Initial Pass/Fail: Fail	Overall Compliance: No
			Severity Score: 21.25

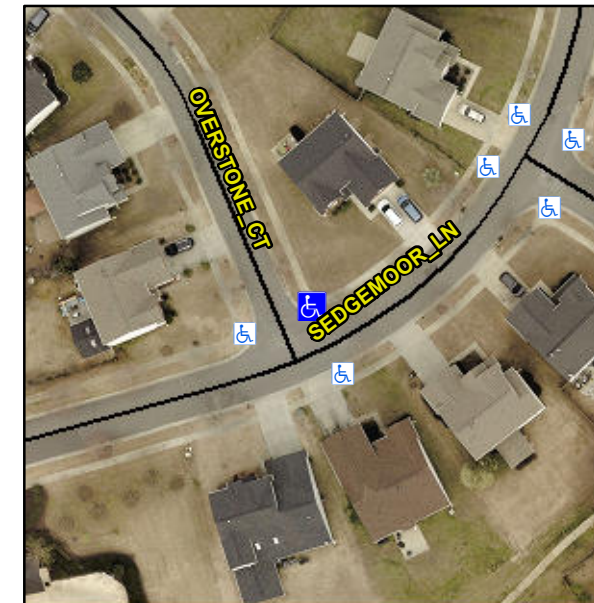
R304.5.1, R304.5.3

Compliance	Description	Data	Compliance	Description	Data
N/A	Ramp Length (in)	68.0	Yes	BlendTrans Slope (%)	4.2
No	Ramp Width (in)	42.0	No	BlendTrans XSlope (%)	6.7
N/A	Flare Type LT	N/A	N/A	Flare Type RT	N/A
N/A	Flare Slope LT (%)	N/A	N/A	Flare Slope RT (%)	N/A
N/A	Flare Traversable LT?	N/A	N/A	Flare Traversable RT?	N/A
N/A	Landing Length (in)	N/A	N/A	DWS Provided?	N/A
N/A	Landing Width (in)	N/A	N/A	DWS Contrast?	N/A
N/A	Landing Slope (%)	N/A	N/A	DWS Length (in)	N/A
N/A	Landing X Slope (%)	N/A	N/A	DWS Full Width?	N/A
N/A	Landing Curb? (Y/N)	N/A	N/A	DWS Offset (in)	N/A
N/A	Shared Landing?	N/A			
N/A	Gutter Ponding?	N/A	N/A	Gutter Slope (%)	N/A
N/A	Gutter Lip Ht (in)	N/A	N/A	Gutter X Slope (%)	N/A
N/A	Painted X Walk1?	No	N/A	Painted X Walk2?	No
	X Walk 1 Direction	To SW		X Walk 2 Direction	To SE
	X Walk 1 Width (in)	N/A		X Walk 2 Width (in)	N/A
	X Walk 1 Slope (%)	1.1		X Walk 2 Slope (%)	0.6
	X Walk 1 X Slope (%)	2.0		X Walk 2 X Slope (%)	0.6

N/A	Ramp inside XWalk1?	N/A	N/A	Ramp inside XWalk2?	N/A
	Road Slope (%)	1.4		Clear Space?	N/A
	Road X Slope (%)	0.2	N/A	Clear Space to XWalk (in)	N/A
N/A	Any Obstructions?	N/A	N/A	Storm Grate/Utility Hazard?	N/A
	Obstruction Type			Storm Grate/Utility Type	
		N/A			N/A
			Yes	Surface Condition? (G/P)	Good
			N/A	Curb Slope (%)	1.2

Remove & Replace Curb Ramp With Two New Directional Ramps or Equivalent.

Total Cost: \$ 3200.00
