Access Compliance Report

Public Rights-of-Way

(Curb Ramps)

Intersection ID: 46754	Main Street: SUPERIOR_ST	Cross Street: TAHOE_DR	Location: W
ADA ID: CBBD252DF14D	Ramp Type: BlendTrans1	Initial Pass/Fail: Fail	Overall Compliance: No
Severity Score: 21.25			
Codes/Mitigation Info/Possible Solution		Field Measurements/Component Compliance

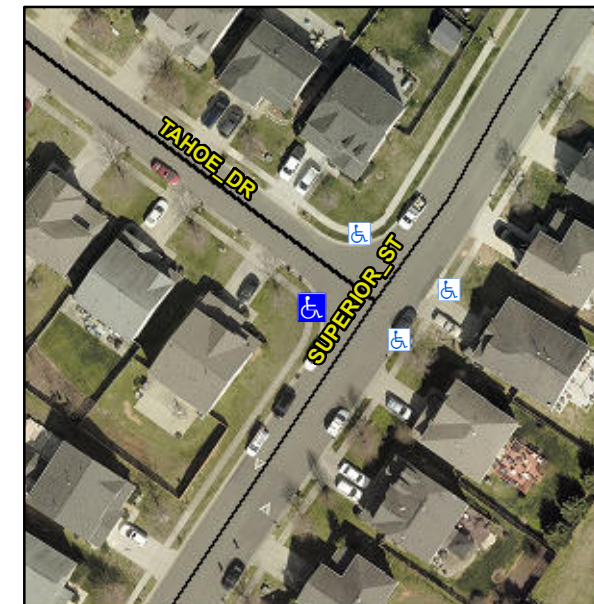
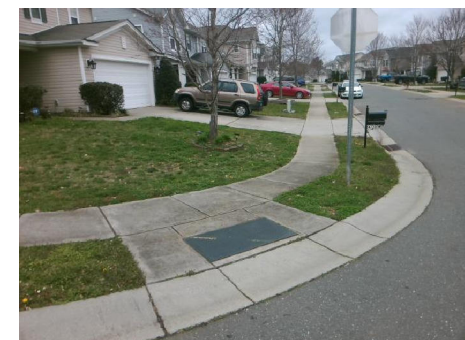
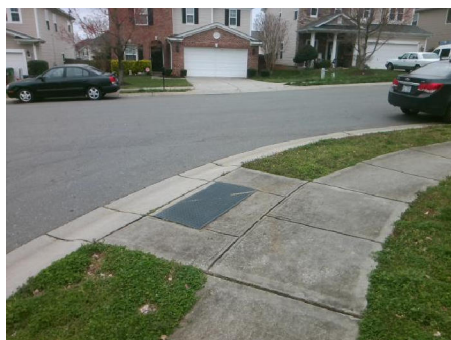
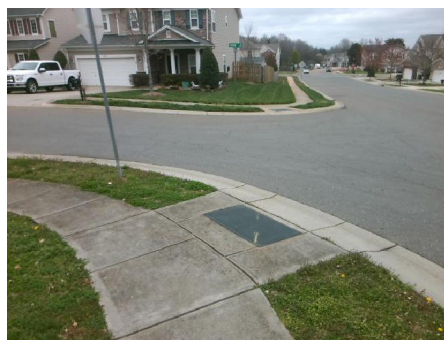
Not Found, R304.5.1, R304.5.3

Compliance	Description	Data	Compliance	Description	Data
N/A	Ramp Length (in)	46.0	Yes	BlendTrans Slope (%)	4.6
No	Ramp Width (in)	43.0	No	BlendTrans XSlope (%)	5.4
N/A	Flare Type LT	N/A	N/A	Flare Type RT	N/A
N/A	Flare Slope LT (%)	N/A	N/A	Flare Slope RT (%)	N/A
N/A	Flare Traversable LT?	N/A	N/A	Flare Traversable RT?	N/A
N/A	Landing Length (in)	N/A	N/A	DWS Provided?	N/A
N/A	Landing Width (in)	N/A	N/A	DWS Contrast?	N/A
N/A	Landing Slope (%)	N/A	N/A	DWS Length (in)	N/A
N/A	Landing X Slope (%)	N/A	N/A	DWS Full Width?	N/A
N/A	Landing Curb? (Y/N)	N/A	N/A	DWS Offset (in)	N/A
N/A	Shared Landing?	N/A			
N/A	Gutter Ponding?	N/A	N/A	Gutter Slope (%)	N/A
N/A	Gutter Lip Ht (in)	N/A	N/A	Gutter X Slope (%)	N/A
N/A	Painted X Walk1?	No	N/A	Painted X Walk2?	No
	X Walk 1 Direction	To SE		X Walk 2 Direction	To NE
	X Walk 1 Width (in)	N/A		X Walk 2 Width (in)	N/A
	X Walk 1 Slope (%)	2.9		X Walk 2 Slope (%)	4.8
	X Walk 1 X Slope (%)	4.6		X Walk 2 X Slope (%)	1.0

N/A	Ramp inside XWalk1?	N/A	N/A	Ramp inside XWalk2?	N/A
	Road Slope (%)	3.1		Clear Space?	N/A
	Road X Slope (%)	5.2	N/A	Clear Space to XWalk (in)	N/A
N/A	Any Obstructions?	N/A	N/A	Storm Grate/Utility Hazard?	N/A
	Obstruction Type			Storm Grate/Utility Type	
		N/A			N/A
			Yes	Surface Condition? (G/P)	Good
			No	Curb Slope (%)	9.9

Remove & Replace Curb Ramp With Two New Directional Ramps or Equivalent.
