Access Compliance Report Public Rights-of-Way (Curb Ramps)

Intersection ID: 21788 Main Street: NOLLEY_CT Cross Street: N/A Location: SE

ADA ID: CBBE1ED66624 Ramp Type: Perp Initial Pass/Fail: Fail Overall Compliance: No Severity Score: 13.75

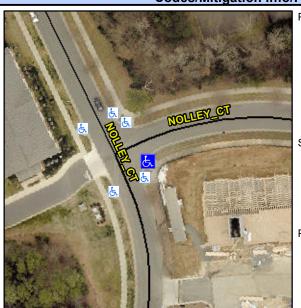
Comp	liance Description	Data			Description	Data
N/A	Ramp Length (in)	95.0	No	Ramp	Slope (%)	8.9
Yes	Ramp Width (in)	48.0	No	Ramp	XSlope (%)	3.2
N/A	Flare Type LT	N/A	N/A	Flare	Type RT	N/A
N/A	Flare Slope LT (%)	N/A	N/A	Flare	Slope RT (%)	N/A
N/A	Flare Traversable LT?	N/A	N/A	Flare	Traversable RT?	N/A
N/A	Landing Length (in)	N/A	N/A	DWS	Provided?	N/A
N/A	Landing Width (in)	N/A	N/A	DWS	Contrast?	N/A
N/A	Landing Slope (%)	N/A	N/A	DWS	Length (in)	N/A
N/A	Landing X Slope (%)	N/A	N/A	DWS	Full Width?	N/A
N/A	Landing Curb? (Y/N)	N/A	N/A	DWS	Offset (in)	N/A
N/A	Shared Landing?	N/A				
N/A	Gutter Ponding?	N/A	N/A	Gutte	r Slope (%)	N/A
N/A	Gutter Lip Ht (in)	N/A	N/A	Gutte	er X Slope (%)	N/A
N/A	Painted X Walk1?	No	N/A	Paint	ed X Walk2?	N/A
	X Walk 1 Direction	To NW		X Wa	lk 2 Direction	N/A
N/A	X Walk 1 Width (in)	N/A	N/A	X Wa	lk 2 Width (in)	N/A
	X Walk 1 Slope (%)	1.8		X Wa	lk 2 Slope (%)	N/A
	X Walk 1 X Slope (%)	3.5		X Wa	lk 2 X Slope (%)	N/A

N/A	Ramp inside XWalk1?	N/A	N/A	Ram	inside XWalk2?	N/A
	Road Slope (%)	N/A	N/A	Clear	Space?	N/A
	Road X Slope (%)	N/A	N/A	Clear	Space to XWalk (in)	N/A
N/A	Any Obstructions?	N/A	N/A	Storn	n Grate/Utility Hazard?	N/A
	Obstruction Type			Storn	n Grate/Utility Type	
		N/A				N/A
			Yes	Surfa	ce Condition? (G/P)	Good

PUSSIBLE SUIULIUII	
Possible Solutions:	
Remove & Replace Entire Ramp.	N
	Y
	N
	1
	1
	1
Surveyor Notes:	1
N/A	1
	1
	1
	1
PROW/ADA:	1
Not Found, R304.2.2, R304.5.3	N
	N
	N
