Access Compliance Report

Public Rights-of-Way

(Curb Ramps)

Intersection ID: 32276	Main Street: SULLIVAN_RIDGE_DR	Cross Street: WILLOUGHBY_RUN_DR	Location: SE
ADA ID: CBC9BDBB24F3	Ramp Type: PerpDiag	Initial Pass/Fail: Fail	Overall Compliance: No
Severity Score: 21.25			
Codes/Mitigation Info/Possible Solution		Field Measurements/Component Compliance

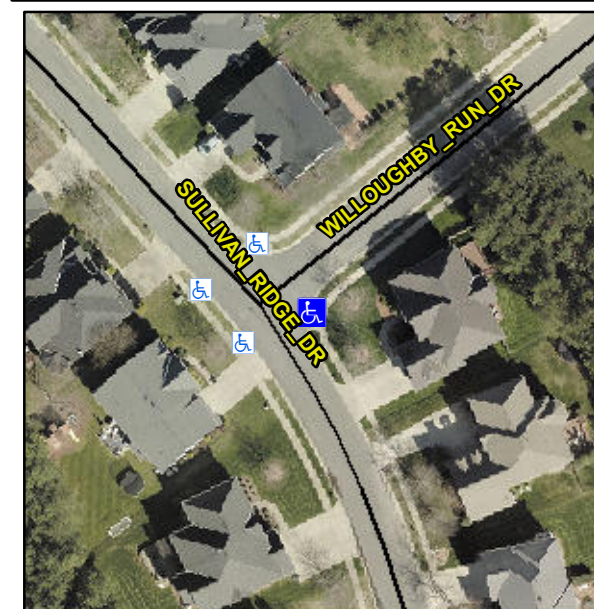
Not Found, R304.5.1, R304.5.3

Compliance	Description	Data	Compliance	Description	Data
N/A	Ramp Length (in)	47.5	Yes	Ramp Slope (%)	6.2
No	Ramp Width (in)	41.0	No	Ramp XSlope (%)	5.3
N/A	Flare Type LT	N/A	N/A	Flare Type RT	N/A
N/A	Flare Slope LT (%)	N/A	N/A	Flare Slope RT (%)	N/A
N/A	Flare Traversable LT?	N/A	N/A	Flare Traversable RT?	N/A
N/A	Landing Length (in)	N/A	N/A	DWS Provided?	N/A
N/A	Landing Width (in)	N/A	N/A	DWS Contrast?	N/A
N/A	Landing Slope (%)	N/A	N/A	DWS Length (in)	N/A
N/A	Landing X Slope (%)	N/A	N/A	DWS Full Width?	N/A
N/A	Landing Curb? (Y/N)	N/A	N/A	DWS Offset (in)	N/A
N/A	Shared Landing?	N/A			
N/A	Gutter Ponding?	N/A	N/A	Gutter Slope (%)	N/A
N/A	Gutter Lip Ht (in)	N/A	N/A	Gutter X Slope (%)	N/A
N/A	Painted X Walk1?	No	N/A	Painted X Walk2?	No
	X Walk 1 Direction	To NW		X Walk 2 Direction	To W
N/A	X Walk 1 Width (in)	N/A	N/A	X Walk 2 Width (in)	N/A
	X Walk 1 Slope (%)	1.4		X Walk 2 Slope (%)	0.0
	X Walk 1 X Slope (%)	0.8		X Walk 2 X Slope (%)	1.9

N/A	Ramp inside XWalk1?	N/A	N/A	Ramp inside XWalk2?	N/A
	Road Slope (%)	1.2	N/A	Clear Space?	N/A
	Road X Slope (%)	0.9	N/A	Clear Space to XWalk (in)	N/A
N/A	Any Obstructions?	N/A	N/A	Storm Grate/Utility Hazard?	N/A
	Obstruction Type			Storm Grate/Utility Type	
		N/A			N/A
			Yes	Surface Condition? (G/P)	Good

Remove & Replace Curb Ramp With Two New Directional Ramps or Equivalent.
