# Access Compliance Report

## Public Rights-of-Way

### (Curb Ramps)

Intersection ID: 3040	Main Street: FOX_GLEN_RD	Cross Street: RED_TAIL_CT	Location: SW
ADA ID: CBCD448B7C54	Ramp Type: Directional1	Initial Pass/Fail: Fail	Overall Compliance: No
Severity Score: 22.5			
Codes/Mitigation Info/Possible Solution		Field Measurements/Component Compliance

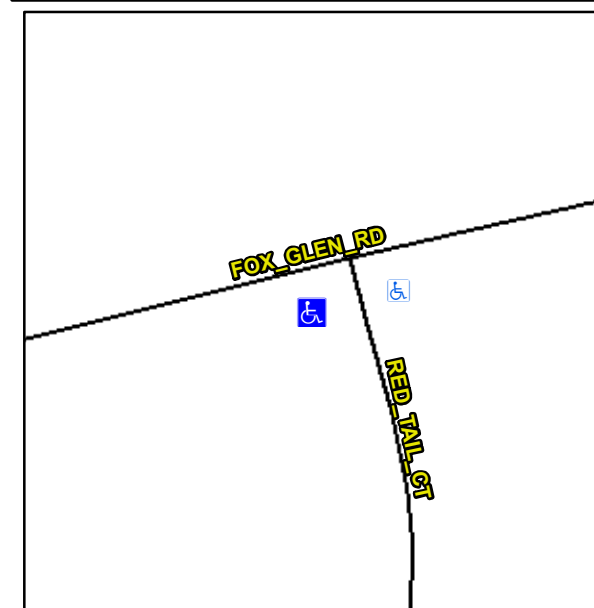
**R304.5.1, R304.2.2, R304.5.3**

Compliance	Description	Data	Compliance	Description	Data
N/A	Ramp Length (in)	120.0	N/A	Grade Break?	N/A
No	Ramp Width (in)	47.0	N/A	Grade Break Slope (%)	0.0
No	Ramp Slope (%)	11.5	N/A	Grade Break XSlope (%)	0.0
No	Ramp XSlope (%)	2.8			
N/A	Flare Type LT	N/A	N/A	Flare Type RT	N/A
N/A	Flare Slope LT (%)	N/A	N/A	Flare Slope RT (%)	0.0
N/A	Flare Traversable LT?	N/A	N/A	Flare Traversable RT?	N/A
N/A	Landing Length (in)	0.0	N/A	DWS Provided?	N/A
N/A	Landing Width (in)	0.0	N/A	DWS Contrast?	N/A
N/A	Landing Slope (%)	0.0	N/A	DWS Length (in)	N/A
N/A	Landing X Slope (%)	0.0	N/A	DWS Full Width?	N/A
N/A	Landing Curb? (Y/N)	N/A	N/A	DWS Offset LT (in)	N/A
N/A	Shared Landing?	N/A	N/A	DWS Offset RT (in)	N/A
N/A	Gutter Ponding?	0.0	N/A	Gutter Slope (%)	N/A
N/A	Gutter Lip Ht (in)	0.0	N/A	Gutter X Slope (%)	N/A
N/A	Painted X Walk1?	No		Road Slope (%)	0.5
	X Walk 1 Direction	To NE		Road X Slope (%)	2.1
	X Walk 1 Width (in)	N/A		Clear Space?	N/A

X Walk 1 Slope (%)	0.5	N/A	Clear Space to XWalk (in)	N/A
	X Walk 1 X Slope (%)	2.1	N/A	Storm Grate/Utility Hazard?	N/A
N/A	Ramp inside XWalk1?	N/A		Storm Grate/Utility Type	
N/A	Any Obstructions?	N/A			N/A
	Obstruction Type		Yes	Surface Condition? (G/P)	Good
			N/A	Curb Slope (%)	N/A

**Remove & Replace Entire Ramp.**
