Access Compliance Report

Public Rights-of-Way

(Curb Ramps)

Intersection ID: 20184	Main Street: SOUTH_PARK_DR	Cross Street: SHARON_RD	Location: SE
ADA ID: CBDED7633878	Ramp Type: PerpDiag	Initial Pass/Fail: Fail	Overall Compliance: No
Severity Score: 10			
Codes/Mitigation Info/Possible Solution		Field Measurements/Component Compliance

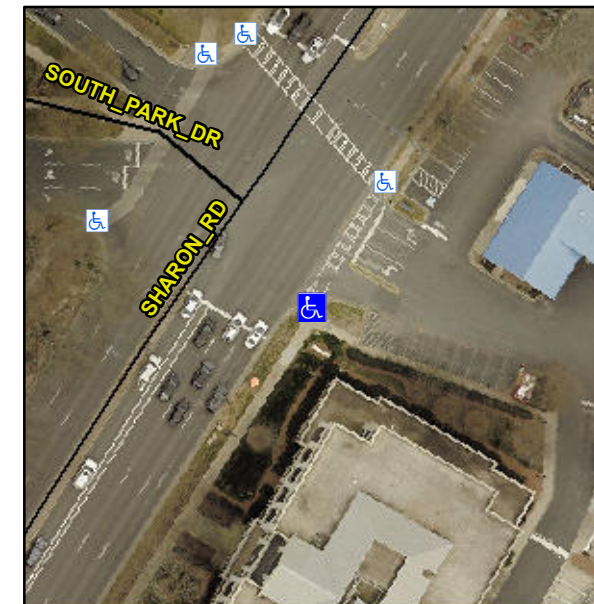
R304.5.1, R304.5.3

Compliance	Description	Data	Compliance	Description	Data
N/A	Ramp Length (in)	82.0	Yes	Ramp Slope (%)	7.1
No	Ramp Width (in)	40.0	No	Ramp XSlope (%)	3.5
N/A	Flare Type LT	N/A	N/A	Flare Type RT	N/A
N/A	Flare Slope LT (%)	N/A	N/A	Flare Slope RT (%)	N/A
N/A	Flare Traversable LT?	N/A	N/A	Flare Traversable RT?	N/A
N/A	Landing Length (in)	N/A	N/A	DWS Provided?	N/A
N/A	Landing Width (in)	N/A	N/A	DWS Contrast?	N/A
N/A	Landing Slope (%)	N/A	N/A	DWS Length (in)	N/A
N/A	Landing X Slope (%)	N/A	N/A	DWS Full Width?	N/A
N/A	Landing Curb? (Y/N)	N/A	N/A	DWS Offset (in)	N/A
N/A	Shared Landing?	N/A			
N/A	Gutter Ponding?	N/A	N/A	Gutter Slope (%)	N/A
N/A	Gutter Lip Ht (in)	0.5	N/A	Gutter X Slope (%)	N/A
N/A	Painted X Walk1?	Yes	N/A	Painted X Walk2?	No
	X Walk 1 Direction	To NE		X Walk 2 Direction	To NW
N/A	X Walk 1 Width (in)	76.0	N/A	X Walk 2 Width (in)	N/A
	X Walk 1 Slope (%)	0.9		X Walk 2 Slope (%)	1.3
	X Walk 1 X Slope (%)	2.9		X Walk 2 X Slope (%)	1.7

N/A	Ramp inside XWalk1?	Yes	N/A	Ramp inside XWalk2?	N/A
	Road Slope (%)	3.1	N/A	Clear Space?	N/A
	Road X Slope (%)	1.9	N/A	Clear Space to XWalk (in)	N/A
N/A	Any Obstructions?	N/A	N/A	Storm Grate/Utility Hazard?	N/A
	Obstruction Type			Storm Grate/Utility Type	
		N/A			N/A
		Yes		Surface Condition? (G/P)	Good

Remove & Replace Curb Ramp With Two New Directional Ramps or Equivalent.
