Intersection ID: 15085	Main Street: CAMPBELL_DR	Cross Street: N_SHARON_AMITY_RD	Location:	NW
ADA ID: CBE9F8DC78EE	Ramp Type: Perp	Initial Pass/Fail: Fail	Overall Compliance: No	Severity Score: 13.75

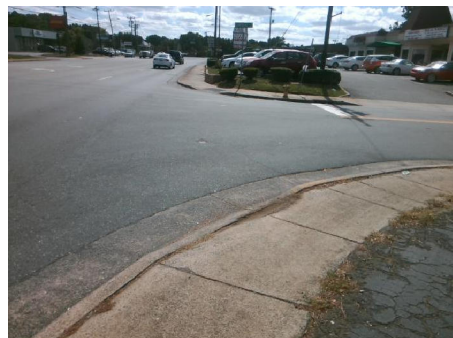
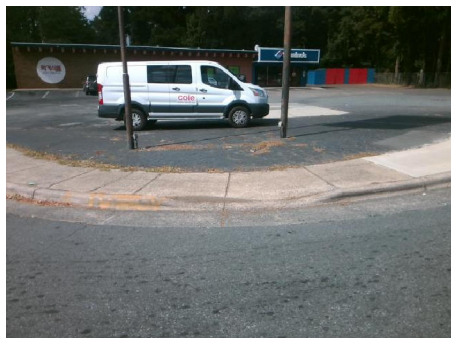
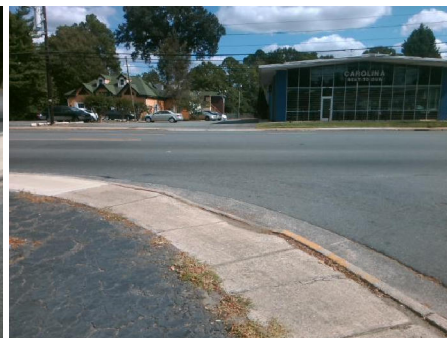
Not Found, R304.2.2, R304.5.3

Possible Solutions:			Compliance	Description	Data	Compliance	Description	Data		
Remove & Replace Entire Ramp.			N/A	Ramp Length (in)	47.5	No	Ramp Slope (%)	10.0		
			Yes	Ramp Width (in)	48.0	No	Ramp XSlope (%)	4.0		
			N/A	Flare Type LT	N/A	N/A	Flare Type RT	N/A		
			N/A	Flare Slope LT (%)	N/A	N/A	Flare Slope RT (%)	N/A		
			N/A	Flare Traversable LT?	N/A	N/A	Flare Traversable RT?	N/A		
			N/A	Landing Length (in)	N/A	N/A	DWS Provided?	N/A		
			N/A	Landing Width (in)	N/A	N/A	DWS Contrast?	N/A		
			N/A	Landing Slope (%)	N/A	N/A	DWS Length (in)	N/A		
			N/A	Landing X Slope (%)	N/A	N/A	DWS Full Width?	N/A		
			N/A	Landing Curb? (Y/N)	N/A	N/A	DWS Offset (in)	N/A		
Surveyor Notes: N/A			N/A	Shared Landing?	N/A					
			N/A	Gutter Ponding?	N/A	N/A	Gutter Slope (%)	N/A		
			N/A	Gutter Lip Ht (in)	N/A	N/A	Gutter X Slope (%)	N/A		
			N/A	Painted X Walk1?	No	N/A	Painted X Walk2?	N/A		
				X Walk 1 Direction	To S		X Walk 2 Direction	N/A

N/A	X Walk 1 Width (in)	N/A	N/A	X Walk 2 Width (in)	N/A		
				X Walk 1 Slope (%)	4.6		X Walk 2 Slope (%)	N/A		
				X Walk 1 X Slope (%)	4.6		X Walk 2 X Slope (%)	N/A		
			N/A	Ramp inside XWalk1?	N/A	N/A	Ramp inside XWalk2?	N/A		
				Road Slope (%)	N/A	N/A	Clear Space?	N/A		
PROW/ADA: Not Found, R304.2.2, R304.5.3				Road X Slope (%)	N/A	N/A	Clear Space to XWalk (in)	N/A		
			N/A	Any Obstructions?	N/A	N/A	Storm Grate/Utility Hazard?	N/A		
				Obstruction Type			Storm Grate/Utility Type			
					N/A			N/A		
						Yes	Surface Condition? (G/P)	Good		
			Total Cost:			\$	1850.00

Remove & Replace Entire Ramp.
