Access Compliance Report

Public Rights-of-Way (Curb Ramps)

Intersection ID: 10023017	Main Street: CENTER_PARK_DR	Cross Street: N/A	Location: SW
ADA ID: CBF1D2B30860	Ramp Type: Directional2	Initial Pass/Fail: Fail	Overall Compliance: No
Severity Score: 42.5			
Codes/Mitigation Info/Possible Solution		Field Measurements/Component Compliance

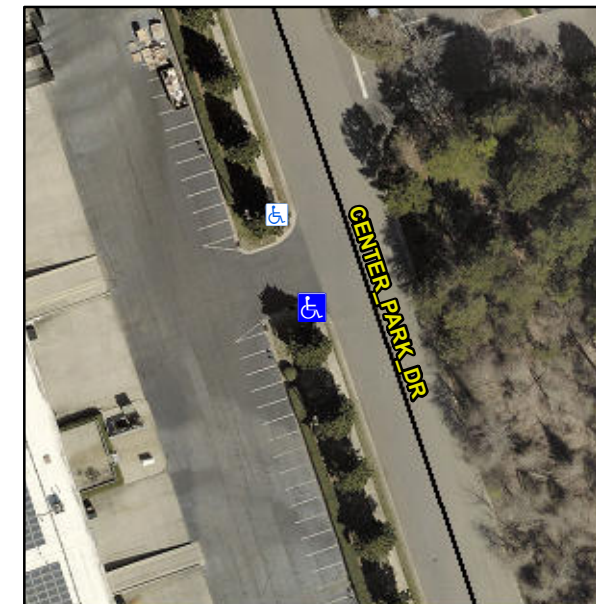
Compliance	Description	Data	Compliance	Description	Data
N/A	Ramp Length (in)	64.0	N/A	Grade Break?	N/A
No	Ramp Width (in)	33.0	N/A	Grade Break Slope (%)	0.0
Yes	Ramp Slope (%)	3.2	N/A	Grade Break XSlope (%)	0.0
No	Ramp XSlope (%)	11.1			
N/A	Flare Type LT	N/A	N/A	Flare Type RT	N/A
N/A	Flare Slope LT (%)	N/A	N/A	Flare Slope RT (%)	0.0
N/A	Flare Traversable LT?	N/A	N/A	Flare Traversable RT?	N/A
N/A	Landing Length (in)	0.0	N/A	DWS Provided?	N/A
N/A	Landing Width (in)	0.0	N/A	DWS Contrast?	N/A
N/A	Landing Slope (%)	0.0	N/A	DWS Length (in)	N/A
N/A	Landing X Slope (%)	0.0	N/A	DWS Full Width?	N/A
N/A	Landing Curb? (Y/N)	N/A	N/A	DWS Offset LT (in)	N/A
N/A	Shared Landing?	N/A	N/A	DWS Offset RT (in)	N/A
N/A	Gutter Ponding?	0.0	N/A	Gutter Slope (%)	N/A
N/A	Gutter Lip Ht (in)	0.0	N/A	Gutter X Slope (%)	N/A
N/A	Painted X Walk1?	No		Road Slope (%)	2.1
	X Walk 1 Direction	To NW		Road X Slope (%)	9.2
	X Walk 1 Width (in)	N/A		Clear Space?	N/A

X Walk 1 Slope (%)	2.1	N/A	Clear Space to XWalk (in)	N/A
	X Walk 1 X Slope (%)	9.2	N/A	Storm Grate/Utility Hazard?	N/A
N/A	Ramp inside XWalk1?	N/A		Storm Grate/Utility Type	
N/A	Any Obstructions?	N/A			N/A
	Obstruction Type		Yes	Surface Condition? (G/P)	Good
			N/A	Curb Slope (%)	8.3

Possible Solutions:

Remove & Replace Entire Ramp.
