Access Compliance Report Public Rights-of-Way (Curb Ramps)

Intersection ID: 13268 Main Street: CENTRAL_AV **Cross Street: LYON_CT** Location: SW

Overall Compliance: No ADA ID: CBF422D20EA3 Ramp Type: Perp Initial Pass/Fail: Fail Severity Score: 13.75

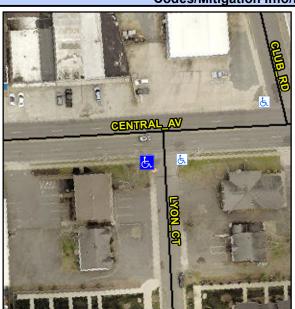
Field Measurements/Component Compliance								
Comp	liance Description	Data	Comp	liance Description	Data			
N/A	Ramp Length (in)	52.5	No	Ramp Slope (%)	8.7			
Yes	Ramp Width (in)	48.0	No	Ramp XSlope (%)	4.8			
N/A	Flare Type LT	N/A	N/A	Flare Type RT	N/A			
N/A	Flare Slope LT (%)	N/A	N/A	Flare Slope RT (%)	N/A			
N/A	Flare Traversable LT?	N/A	N/A	Flare Traversable RT?	N/A			
N/A	Landing Length (in)	N/A	N/A	DWS Provided?	N/A			
N/A	Landing Width (in)	N/A	N/A	DWS Contrast?	N/A			
N/A	Landing Slope (%)	N/A	N/A	DWS Length (in)	N/A			
N/A	Landing X Slope (%)	N/A	N/A	DWS Full Width?	N/A			
N/A	Landing Curb? (Y/N)	N/A	N/A	DWS Offset (in)	N/A			
N/A	Shared Landing?	N/A						
N/A	Gutter Ponding?	Yes	N/A	Gutter Slope (%)	N/A			
N/A	Gutter Lip Ht (in)	N/A	N/A	Gutter X Slope (%)	N/A			
N/A	Painted X Walk1?	No	N/A	Painted X Walk2?	N/A			
	X Walk 1 Direction	To E		X Walk 2 Direction	N/A			
N/A	X Walk 1 Width (in)	N/A	N/A	X Walk 2 Width (in)	N/A

X Walk 1 Slope (%)	7.1		X Walk 2 Slope (%)	N/A			
	X Walk 1 X Slope (%)	3.6		X Walk 2 X Slope (%)	N/A			
N/A	Ramp inside XWalk1?	N/A	N/A	Ramp inside XWalk2?	N/A			
	Road Slope (%)	N/A	N/A	Clear Space?	N/A			
	Road X Slope (%)	N/A	N/A	Clear Space to XWalk (in)	N/A			
N/A	Any Obstructions?	N/A	N/A	Storm Grate/Utility Hazard	? N/A			
	Obstruction Type			Storm Grate/Utility Type				
		N/A			N/A			
			Yes	Surface Condition? (G/P)	Good

Possible Solutions:						
Remove & Replace Entire Ramp.						
Surveyor Notes:						
N/A						
PROW/ADA:						
R304.2.2, R304.5.3
