Intersection ID: 13818	Main Street: CENTRAL_AV	Cross Street: SHERIDAN_DR	Location:	SW
ADA ID: CC07D133E0F5	Ramp Type: Perp	Initial Pass/Fail: Fail	Overall Compliance: No	Severity Score: 17.5

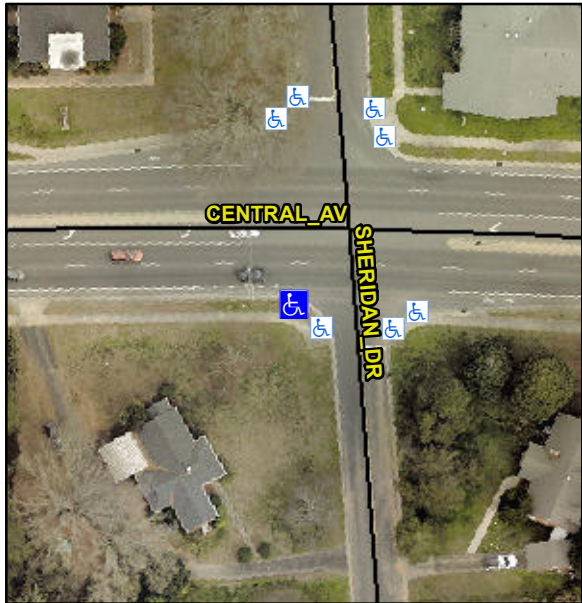
Possible Solutions:		Compliance	Description	Data	Compliance	Description	Data
	Remove & Replace Entire Ramp.		N/A	Ramp Length (in)	71.5	Yes	Ramp Slope (%)	6.3
			No	Ramp Width (in)	35.0	Yes	Ramp XSlope (%)	1.2
			N/A	Flare Type LT	N/A	N/A	Flare Type RT	N/A
			N/A	Flare Slope LT (%)	N/A	N/A	Flare Slope RT (%)	N/A
			N/A	Flare Traversable LT?	N/A	N/A	Flare Traversable RT?	N/A
			N/A	Landing Length (in)	N/A	N/A	DWS Provided?	N/A
Surveyor Notes:			N/A	Landing Width (in)	N/A	N/A	DWS Contrast?	N/A
N/A			N/A	Landing Slope (%)	N/A	N/A	DWS Length (in)	N/A
			N/A	Landing X Slope (%)	N/A	N/A	DWS Full Width?	N/A
			N/A	Landing Curb? (Y/N)	N/A	N/A	DWS Offset (in)	N/A
			N/A	Shared Landing?	N/A			
PROW/ADA:			N/A	Gutter Ponding?	N/A	N/A	Gutter Slope (%)	N/A
Not Found, R304.5.1			N/A	Gutter Lip Ht (in)	N/A	N/A	Gutter X Slope (%)	N/A

N/A	Painted X Walk1?	No	N/A	Painted X Walk2?	N/A
				X Walk 1 Direction	To N		X Walk 2 Direction	N/A
			N/A	X Walk 1 Width (in)	N/A	N/A	X Walk 2 Width (in)	N/A
				X Walk 1 Slope (%)	3.1		X Walk 2 Slope (%)	N/A
				X Walk 1 X Slope (%)	0.2		X Walk 2 X Slope (%)	N/A
			N/A	Ramp inside XWalk1?	N/A	N/A	Ramp inside XWalk2?	N/A
				Road Slope (%)	N/A	N/A	Clear Space?	N/A
				Road X Slope (%)	N/A	N/A	Clear Space to XWalk (in)	N/A
			N/A	Any Obstructions?	N/A	N/A	Storm Grate/Utility Hazard?	N/A
Total Cost:	\$	1850.00		Obstruction Type			Storm Grate/Utility Type	
					N/A			N/A
						Yes	Surface Condition? (G/P)	Good
