Access Compliance Report Public Rights-of-Way (Curb Ramps)

Intersection ID: 22076 Main Street: HEATHSTEAD_PL Cross Street: QUAIL_HOLLOW_RD Location: NW

ADA ID: CC0C416D42B6 Ramp Type: PerpDiag Initial Pass/Fail: Fail Overall Compliance: No Severity Score: 21.25

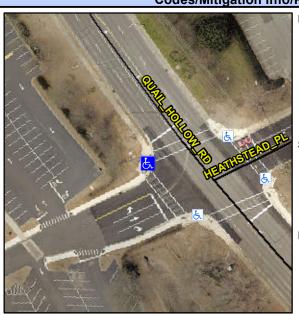
Not Found, R304.5.1, R304.2.2

Compliance Description		Data	Comp	liance Description	Data
N/A	Ramp Length (in)	96.0	No	Ramp Slope (%)	8.6
No	Ramp Width (in)	41.0	Yes	Ramp XSlope (%)	2.0
N/A	Flare Type LT	N/A	N/A	Flare Type RT	N/A
N/A	Flare Slope LT (%)	N/A	N/A	Flare Slope RT (%)	N/A
N/A	Flare Traversable LT?	N/A	N/A	Flare Traversable RT?	N/A
N/A	Landing Length (in)	N/A	N/A	DWS Provided?	N/A
N/A	Landing Width (in)	N/A	N/A	DWS Contrast?	N/A
N/A	Landing Slope (%)	N/A	N/A	DWS Length (in)	N/A
N/A	Landing X Slope (%)	N/A	N/A	DWS Full Width?	N/A
N/A	Landing Curb? (Y/N)	N/A	N/A	DWS Offset (in)	N/A
N/A	Shared Landing?	N/A			
N/A	Gutter Ponding?	N/A	N/A	Gutter Slope (%)	N/A
N/A	Gutter Lip Ht (in)	N/A	N/A	Gutter X Slope (%)	N/A
N/A	Painted X Walk1?	No	N/A	Painted X Walk2?	No
	X Walk 1 Direction	To SE		X Walk 2 Direction	To NE
N/A	X Walk 1 Width (in)	N/A	N/A	X Walk 2 Width (in)	N/A
	X Walk 1 Slope (%)	1.6		X Walk 2 Slope (%)	2.5
	X Walk 1 X Slope (%)	0.4		X Walk 2 X Slope (%)	1.6

Remove & Replace Curb Ramp With
Two New Directional Ramps or
Equivalent.
