Access Compliance Report

Public Rights-of-Way

(Curb Ramps)

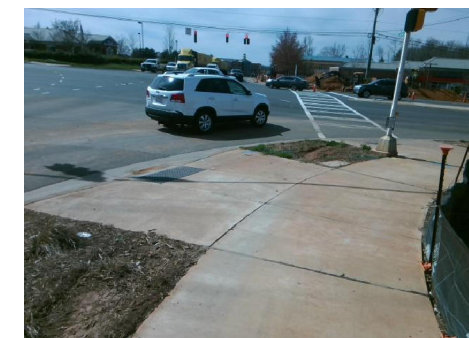
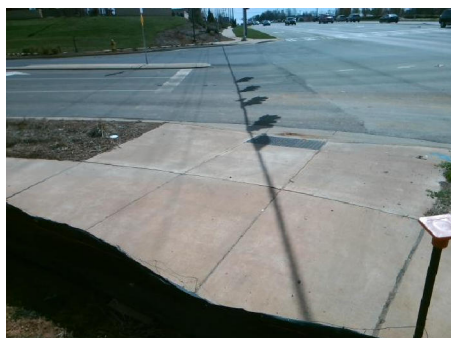
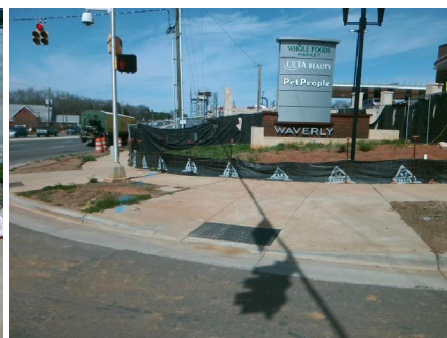
Intersection ID: 30613	Main Street: GOLF_LINKS_DR	Cross Street: PROVIDENCE_RD	Location: NE
ADA ID: CC0F7375E97B	Ramp Type: Perp	Initial Pass/Fail: Fail	Overall Compliance: No
Codes/Mitigation Info/Possible Solution			Severity Score: 10
			Field Measurements/Component Compliance

Not Found, R304.5.1, R304.5.3

Compliance	Description	Data	Compliance	Description	Data
N/A	Ramp Length (in)	96.0	Yes	Ramp Slope (%)	7.2
No	Ramp Width (in)	47.5	No	Ramp XSlope (%)	3.0
N/A	Flare Type LT	N/A	N/A	Flare Type RT	N/A
N/A	Flare Slope LT (%)	N/A	N/A	Flare Slope RT (%)	N/A
N/A	Flare Traversable LT?	N/A	N/A	Flare Traversable RT?	N/A
N/A	Landing Length (in)	N/A	N/A	DWS Provided?	N/A
N/A	Landing Width (in)	N/A	N/A	DWS Contrast?	N/A
N/A	Landing Slope (%)	N/A	N/A	DWS Length (in)	N/A
N/A	Landing X Slope (%)	N/A	N/A	DWS Full Width?	N/A
N/A	Landing Curb? (Y/N)	N/A	N/A	DWS Offset (in)	N/A
N/A	Shared Landing?	N/A			
N/A	Gutter Ponding?	N/A	N/A	Gutter Slope (%)	N/A
N/A	Gutter Lip Ht (in)	N/A	N/A	Gutter X Slope (%)	N/A
N/A	Painted X Walk1?	No	N/A	Painted X Walk2?	N/A
	X Walk 1 Direction	To S		X Walk 2 Direction	N/A
N/A	X Walk 1 Width (in)	N/A	N/A	X Walk 2 Width (in)	N/A
	X Walk 1 Slope (%)	2.2		X Walk 2 Slope (%)	N/A
	X Walk 1 X Slope (%)	1.4		X Walk 2 X Slope (%)	N/A

N/A	Ramp inside XWalk1?	N/A	N/A	Ramp inside XWalk2?	N/A
	Road Slope (%)	N/A	N/A	Clear Space?	N/A
	Road X Slope (%)	N/A	N/A	Clear Space to XWalk (in)	N/A
N/A	Any Obstructions?	N/A	N/A	Storm Grate/Utility Hazard?	N/A
	Obstruction Type			Storm Grate/Utility Type	
		N/A			N/A
			Yes	Surface Condition? (G/P)	Good

Remove & Replace Entire Ramp.
