# Access Compliance Report

## Public Rights-of-Way

### (Curb Ramps)

| Intersection ID: 49248 | Main Street: BOOMERANG_WY | Cross Street: PROSPERITY_VIEW_DR | Location: SE |

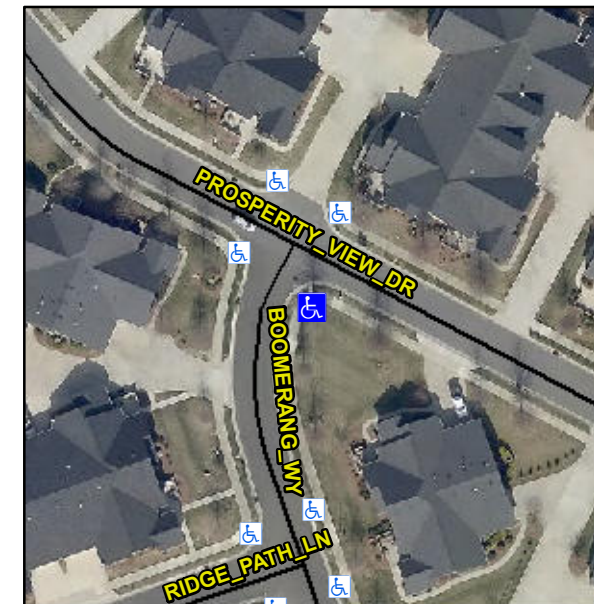
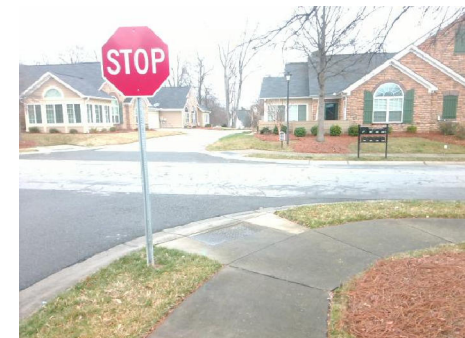
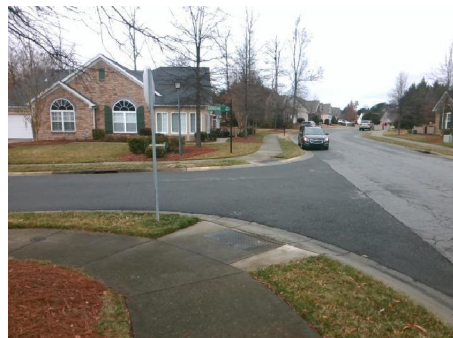
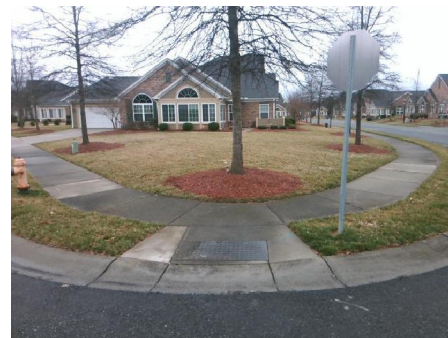
| ADA ID: CC0FAEED7C53 | Ramp Type: BlendTrans1 | Initial Pass/Fail: Pass | Overall Compliance: No |
| Severity Score: 0 | | | |

**Not Found, R305.2**

| Compliance | Description | Data | Compliance | Description | Data |
|---|---|---|---|---|---|
| N/A | Landing Curb? (Y/N) | No | No | DWS Offset (in) | 6.0 |
| | | | No | Curb Slope (%) | 10.3 |

**Remove & Replace Curb Ramp With Two New Directional Ramps or Equivalent.**

Total Cost: \$ 3200.00
