# Access Compliance Report

## Public Rights-of-Way

### (Curb Ramps)

Intersection ID: 21209	Main Street: GALLERIA_BV	Cross Street: SARDIS_RD_NORTH	Location: SW
ADA ID: CC231DD7904F	Ramp Type: Perp	Initial Pass/Fail: Fail	Overall Compliance: No
Severity Score: 21.25			
Codes/Mitigation Info/Possible Solution		Field Measurements/Component Compliance

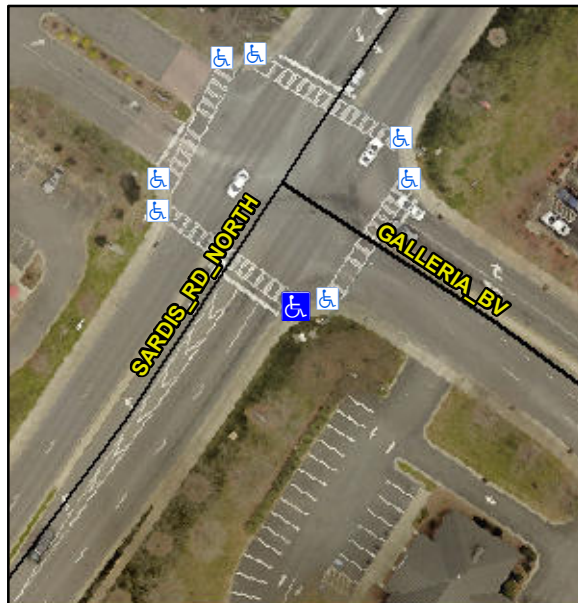
Compliance	Description	Data	Compliance	Description	Data
N/A	Ramp Length (in)	72.0	Yes	Ramp Slope (%)	7.6
No	Ramp Width (in)	40.5	No	Ramp XSlope (%)	5.1
N/A	Flare Type LT	N/A	N/A	Flare Type RT	N/A
N/A	Flare Slope LT (%)	N/A	N/A	Flare Slope RT (%)	N/A
N/A	Flare Traversable LT?	N/A	N/A	Flare Traversable RT?	N/A
N/A	Landing Length (in)	N/A	N/A	DWS Provided?	N/A
N/A	Landing Width (in)	N/A	N/A	DWS Contrast?	N/A
N/A	Landing Slope (%)	N/A	N/A	DWS Length (in)	N/A
N/A	Landing X Slope (%)	N/A	N/A	DWS Full Width?	N/A
N/A	Landing Curb? (Y/N)	N/A	N/A	DWS Offset (in)	N/A
N/A	Shared Landing?	N/A			
N/A	Gutter Ponding?	N/A	N/A	Gutter Slope (%)	N/A
N/A	Gutter Lip Ht (in)	N/A	N/A	Gutter X Slope (%)	N/A
N/A	Painted X Walk1?	Yes	N/A	Painted X Walk2?	N/A
	X Walk 1 Direction	To NW		X Walk 2 Direction	N/A
N/A	X Walk 1 Width (in)	98.0	N/A	X Walk 2 Width (in)	N/A
	X Walk 1 Slope (%)	0.3		X Walk 2 Slope (%)	N/A
	X Walk 1 X Slope (%)	2.9		X Walk 2 X Slope (%)	N/A

N/A	Ramp inside XWalk1?	Yes	N/A	Ramp inside XWalk2?	N/A
	Road Slope (%)	N/A	N/A	Clear Space?	N/A
	Road X Slope (%)	N/A	N/A	Clear Space to XWalk (in)	N/A
N/A	Any Obstructions?	N/A	N/A	Storm Grate/Utility Hazard?	N/A
	Obstruction Type			Storm Grate/Utility Type	
		N/A			N/A
		Yes		Surface Condition? (G/P)	Good

**Remove & Replace Entire Ramp.**

**R304.5.1, R304.5.3**

Total Cost: \$ 1850.00
