# Access Compliance Report

## Public Rights-of-Way

### (Curb Ramps)

| Intersection ID: 53893 | Main Street: PERTH_MOOR_RD | Cross Street: HAMILTON_BRIDGE_RD | Location: SE |

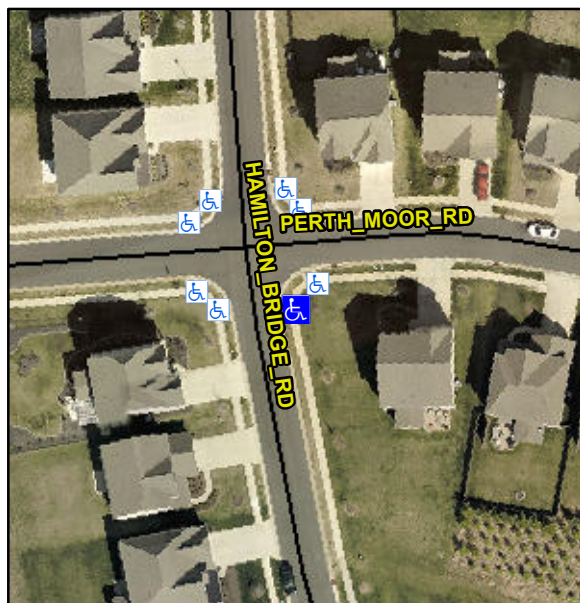
| ADA ID: CC38819AE319 | Ramp Type: Perp | Initial Pass/Fail: Fail | Overall Compliance: No |
| Severity Score: 8.75 | | | |

**Not Found, R304.5.1**

| Compliance | Description | Data | Compliance | Description | Data |
|---|---|---|---|---|---|
| No | Ramp Width (in) | 45.0 | Yes | Ramp XSlope (%) | 0.4 |

**Remove & Replace Entire Ramp.**

Total Cost: \$ 1850.00
