Intersection ID: 10034609	Main Street: PLANTATION_CENTER_DR	Cross Street: N/A	Location:	S
ADA ID: CC3D4A428B01	Ramp Type: Para	Initial Pass/Fail: Fail	Overall Compliance: No	Severity Score: 13.75

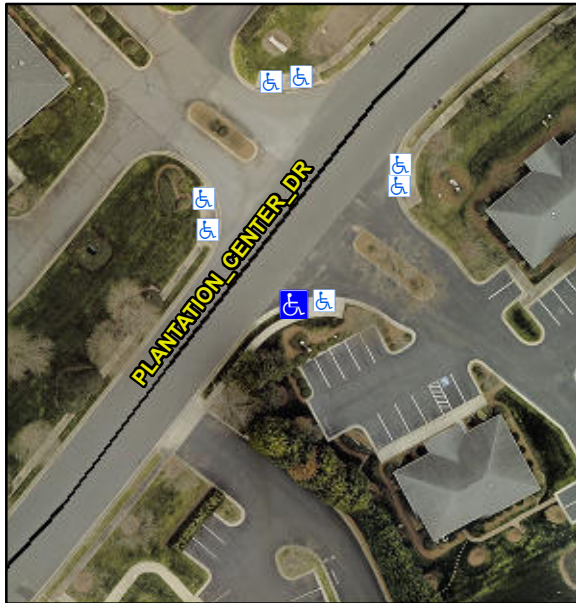
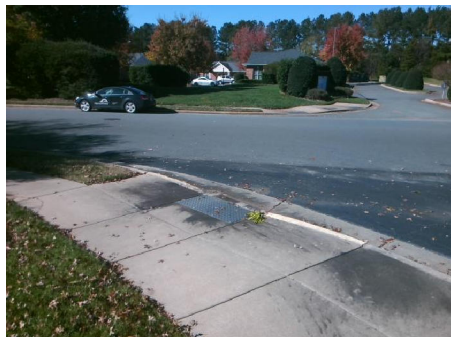
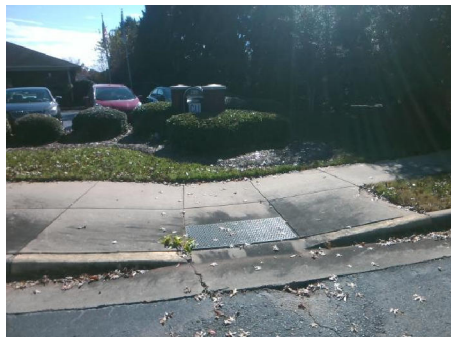
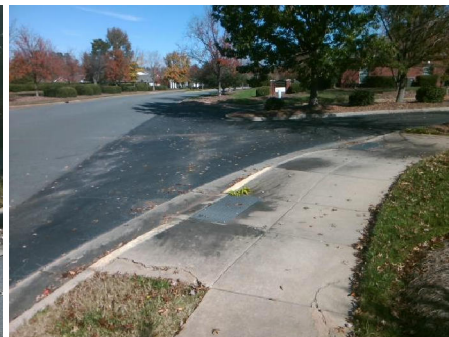
**R304.3.2, R304.5.3**

Possible Solutions:			Compliance	Description	Data	Compliance	Description	Data
<b>Remove &amp; Replace Entire Ramp.</b>			N/A	Ramp Length LT (in)	55.0	N/A	Ramp Length RT (in)	54.0
			Yes	Ramp Width LT (in)	97.0	Yes	Ramp Width RT (in)	97.0
			No	Ramp Slope LT (%)	11.2	Yes	Ramp Slope RT (%)	5.7
			No	Ramp XSlope LT (%)	4.3	Yes	Ramp XSlope RT (%)	1.2
			N/A	Landing Length (in)	N/A	N/A	DWS Provided?	N/A
			N/A	Landing Width (in)	N/A	N/A	DWS Contrast?	N/A
Surveyor Notes:			N/A	Landing Slope (%)	N/A	N/A	DWS Length (in)	N/A
	<b>N/A</b>		N/A	Landing X Slope (%)	N/A	N/A	DWS Full Width?	N/A
			N/A	Landing Curb? (Y/N)	N/A	N/A	DWS Offset (in)	N/A
			N/A	Shared Landing?	N/A			
			N/A	Gutter Ponding?	N/A	N/A	Gutter Slope (%)	N/A
PROW/ADA:			N/A	Gutter Lip Ht (in)	N/A	N/A	Gutter X Slope (%)	N/A
	<b>R304.3.2, R304.5.3</b>		N/A	Painted X Walk1?	No	N/A	Painted X Walk2?	N/A
				X Walk 1 Direction	To NW		X Walk 2 Direction	N/A

N/A	X Walk 1 Width (in)	N/A	N/A	X Walk 2 Width (in)	N/A
				X Walk 1 Slope (%)	3.4		X Walk 2 Slope (%)	N/A
				X Walk 1 X Slope (%)	0.4		X Walk 2 X Slope (%)	N/A
			N/A	Ramp inside XWalk1?	N/A	N/A	Ramp inside XWalk2?	N/A
				Road Slope (%)	N/A	N/A	Clear Space?	N/A
				Road X Slope (%)	N/A	N/A	Clear Space to XWalk (in)	N/A
			N/A	Any Obstructions?	N/A	N/A	Storm Grate/Utility Hazard?	N/A
				Obstruction Type			Storm Grate/Utility Type	
Total Cost:	\$	1600.00			N/A			N/A
						Yes	Surface Condition? (G/P)	Good
						N/A	Curb Slope (%)	8.5

### Remove & Replace Entire Ramp.
