Access Compliance Report Public Rights-of-Way (Curb Ramps)

Intersection ID: 2905Main Street:RIDGE_RDCross Street:SHELLEY_AVLocation:NEADA ID: CC3D727E14D3Ramp Type:PerpInitial Pass/Fail:FailOverall Compliance:NoSeverity Score:21.25

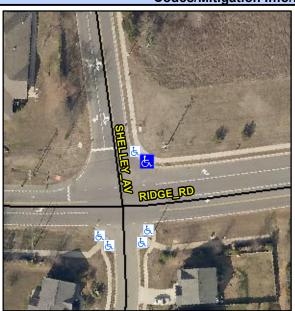
| Possible Solution | |
|---|---|
| R304.5.1, R304.2.2 | N/A |

| Field Measurements/Component Compliance | | | | | | |
|---|---|---|---|---|---|--|
| N/A | Ramp Length (in) | 48.0 | No | Ramp Slope (%) | 8.4 | |
| No | Ramp Width (in) | 47.5 | Yes | Ramp XSlope (%) | 0.5 | |

| Possible Solution | |
|---|---|
| Remove & Replace Entire Ramp. | N/A |
