Access Compliance Report Public Rights-of-Way (Curb Ramps)

Intersection ID: 43116 Main Street: CENTRAL_AV Cross Street: PECAN_AV Location: SE

ADA ID: CC3E35C7334F Ramp Type: Perp Initial Pass/Fail: Fail Overall Compliance: No Severity Score: 17.5

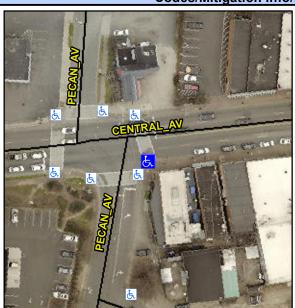
Possible Solutions:	Comp	oliance Description	Data	Compli	ance Description	Data
Remove & Replace Entire Ramp.	N/A	Ramp Length (in)	66.0	Yes	Ramp Slope (%)	7.8
	No	Ramp Width (in)	33.0	Yes	Ramp XSlope (%)	1.0
	N/A	Flare Type LT	N/A	N/A	Flare Type RT	N/A
	N/A	Flare Slope LT (%)	N/A	N/A	Flare Slope RT (%)	N/A
	N/A	Flare Traversable LT?	N/A	N/A	Flare Traversable RT?	N/A
	N/A	Landing Length (in)	N/A	N/A	DWS Provided?	N/A
Surveyor Notes:	N/A	Landing Width (in)	N/A	N/A	DWS Contrast?	N/A
N/A	N/A	Landing Slope (%)	N/A	N/A	DWS Length (in)	N/A
	N/A	Landing X Slope (%)	N/A	N/A	DWS Full Width?	N/A
	N/A	Landing Curb? (Y/N)	N/A	N/A	DWS Offset (in)	N/A
	N/A	Shared Landing?	N/A			
PROW/ADA:	N/A	Gutter Ponding?	N/A	N/A	Gutter Slope (%)	N/A
Not Found, R304.5.1	N/A	Gutter Lip Ht (in)	N/A	N/A	Gutter X Slope (%)	N/A
	N/A	Painted X Walk1?	Yes	N/A	Painted X Walk2?	N/A
		X Walk 1 Direction	To N		X Walk 2 Direction	N/A
	N/A	X Walk 1 Width (in)	143.0	N/A	X Walk 2 Width (in)	N/A

X Walk 1 Slope (%)	1.4		X Walk 2 Slope (%)	N/A
		X Walk 1 X Slope (%)	1.1		X Walk 2 X Slope (%)	N/A
	N/A	Ramp inside XWalk1?	Yes	N/A	Ramp inside XWalk2?	N/A
		Road Slope (%)	N/A	N/A	Clear Space?	N/A
		Road X Slope (%)	N/A	N/A	Clear Space to XWalk (in)	N/A
	N/A	Any Obstructions?	N/A	N/A	Storm Grate/Utility Hazard?	N/A
Total Cost: \$ 18	50.00	Obstruction Type			Storm Grate/Utility Type	
			N/A			N/A
