Access Compliance Report

Public Rights-of-Way

(Curb Ramps)

Intersection ID: 46343	Main Street: MEADOW_KNOLL_DR	Cross Street: STREAM_BANK_DR	Location: SE
ADA ID: CC53A3CE4D6D	Ramp Type: BlendTrans1	Initial Pass/Fail: Fail	Overall Compliance: No
		Severity Score: 47.5

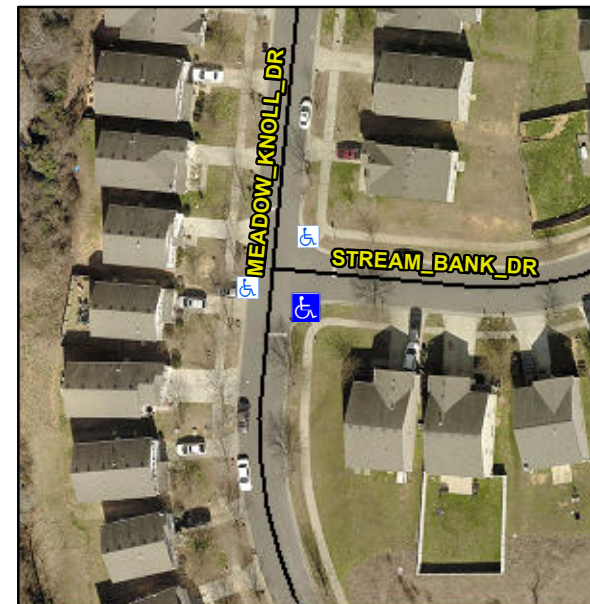
CURB GAP 1.0

Not Found, R304.5.1, R304.5.3

Compliance	Description	Data	Compliance	Description	Data
N/A	Ramp Length (in)	84.0	Yes	BlendTrans Slope (%)	4.5
No	Ramp Width (in)	31.5	No	BlendTrans XSlope (%)	6.0
N/A	Flare Type LT	N/A	N/A	Flare Type RT	N/A
N/A	Flare Slope LT (%)	N/A	N/A	Flare Slope RT (%)	N/A
N/A	Flare Traversable LT?	N/A	N/A	Flare Traversable RT?	N/A
N/A	Landing Length (in)	N/A	N/A	DWS Provided?	N/A
N/A	Landing Width (in)	N/A	N/A	DWS Contrast?	N/A
N/A	Landing Slope (%)	N/A	N/A	DWS Length (in)	N/A
N/A	Landing X Slope (%)	N/A	N/A	DWS Full Width?	N/A
N/A	Landing Curb? (Y/N)	N/A	N/A	DWS Offset (in)	N/A
N/A	Shared Landing?	N/A			
N/A	Gutter Ponding?	N/A	N/A	Gutter Slope (%)	N/A
N/A	Gutter Lip Ht (in)	N/A	N/A	Gutter X Slope (%)	N/A
N/A	Painted X Walk1?	No	N/A	Painted X Walk2?	No
	X Walk 1 Direction	To N		X Walk 2 Direction	To W
	X Walk 1 Width (in)	N/A		X Walk 2 Width (in)	N/A
	X Walk 1 Slope (%)	7.3		X Walk 2 Slope (%)	4.5
	X Walk 1 X Slope (%)	1.5		X Walk 2 X Slope (%)	7.9

N/A	Ramp inside XWalk1?	N/A	N/A	Ramp inside XWalk2?	N/A
	Road Slope (%)	2.9		Clear Space?	N/A
	Road X Slope (%)	6.9	N/A	Clear Space to XWalk (in)	N/A
N/A	Any Obstructions?	N/A	N/A	Storm Grate/Utility Hazard?	N/A
	Obstruction Type			Storm Grate/Utility Type	
		N/A			N/A
			Yes	Surface Condition? (G/P)	Good
			No	Curb Slope (%)	15.0

Possible Solutions:

Remove & Replace Curb Ramp With Two New Directional Ramps or Equivalent.
