# Access Compliance Report

## Public Rights-of-Way

### (Curb Ramps)

| Intersection ID: 12080 | Main Street: E_15TH_ST | Cross Street: SEIGLE_AV | Location: | N |

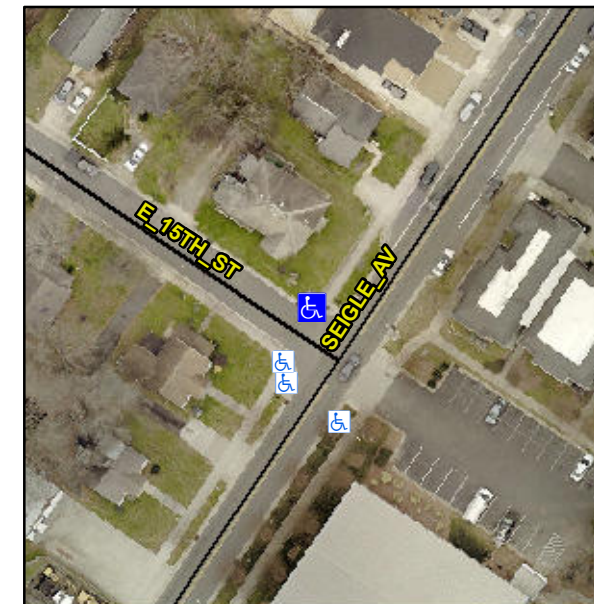
| ADA ID: CC59016E0CF4 | Ramp Type: Perp | Initial Pass/Fail: Fail | Overall Compliance: No | Severity Score: 12.5 |

**Not Found, R304.2.2**

| Compliance | Description | Data | Compliance | Description | Data |
|---|---|---|---|---|---|
| N/A | Ramp Length (in) | 70.5 | No | Ramp Slope (%) | 9.0 |

**Remove & Replace Entire Ramp.**
