## Access Compliance Report Public Rights-of-Way (Curb Ramps)

Intersection ID: 49934 Main Street: MARVIN\_RD Cross Street: CHAMBERLIN\_RD Location: SE

ADA ID: CC5B2095B2F3 Ramp Type: Perp Initial Pass/Fail: Fail Overall Compliance: No Severity Score: 13.75

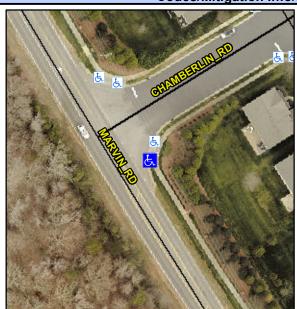
Not Found, R304.2.2

| Field Measurements/Component Compnance | | | | | | |
|--|---|---|---|---|---|--|
| N/A | Ramp Length (in) | 48.0 | No | Ramp Slope (%) | 9.1 | |

Remove & Replace Entire Ramp.
