Access Compliance Report

Public Rights-of-Way

(Curb Ramps)

Intersection ID: 47279	Main Street: SAVANNAH_HILLS_DR	Cross Street: CARRINGTON_FOREST_LN	Location: E
ADA ID: CC5FA5715D96	Ramp Type: PerpDiag	Initial Pass/Fail: Fail	Overall Compliance: No
		Severity Score: 12.5

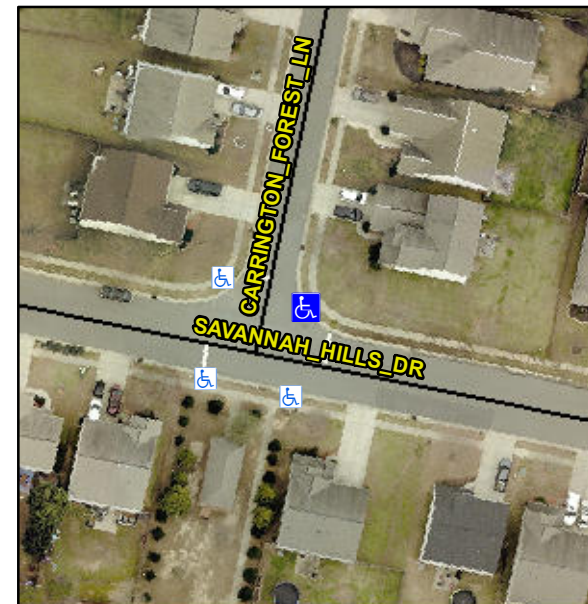
Compliance	Description	Data	Compliance	Description	Data
N/A	Ramp Length (in)	47.0	No	Ramp Slope (%)	9.4
Yes	Ramp Width (in)	48.0	Yes	Ramp XSlope (%)	1.8
N/A	Flare Type LT	N/A	N/A	Flare Type RT	N/A
N/A	Flare Slope LT (%)	N/A	N/A	Flare Slope RT (%)	N/A
N/A	Flare Traversable LT?	N/A	N/A	Flare Traversable RT?	N/A
N/A	Landing Length (in)	N/A	N/A	DWS Provided?	N/A
N/A	Landing Width (in)	N/A	N/A	DWS Contrast?	N/A
N/A	Landing Slope (%)	N/A	N/A	DWS Length (in)	N/A
N/A	Landing X Slope (%)	N/A	N/A	DWS Full Width?	N/A
N/A	Landing Curb? (Y/N)	N/A	N/A	DWS Offset (in)	N/A
N/A	Shared Landing?	N/A			
N/A	Gutter Ponding?	N/A	N/A	Gutter Slope (%)	N/A
N/A	Gutter Lip Ht (in)	N/A	N/A	Gutter X Slope (%)	N/A
N/A	Painted X Walk1?	No	N/A	Painted X Walk2?	No
	X Walk 1 Direction	To NW		X Walk 2 Direction	To SW
N/A	X Walk 1 Width (in)	N/A	N/A	X Walk 2 Width (in)	N/A
	X Walk 1 Slope (%)	3.5		X Walk 2 Slope (%)	4.9
	X Walk 1 X Slope (%)	0.9		X Walk 2 X Slope (%)	4.4

N/A	Ramp inside XWalk1?	N/A	N/A	Ramp inside XWalk2?	N/A
	Road Slope (%)	2.7	N/A	Clear Space?	N/A
	Road X Slope (%)	1.0	N/A	Clear Space to XWalk (in)	N/A
N/A	Any Obstructions?	N/A	N/A	Storm Grate/Utility Hazard?	N/A
	Obstruction Type			Storm Grate/Utility Type	
		N/A			N/A
			Yes	Surface Condition? (G/P)	Good

Possible Solutions:

Remove & Replace Curb Ramp With Two New Directional Ramps or Equivalent.
