Access Compliance Report

Public Rights-of-Way

(Curb Ramps)

Intersection ID: N/A	Main Street: BEVINGTON_PL	Cross Street: N/A	Location: NW
ADA ID: CC675F8CE5F2	Ramp Type: Perp	Initial Pass/Fail: Fail	Overall Compliance: No
Severity Score: 25			
Codes/Mitigation Info/Possible Solution		Field Measurements/Component Compliance

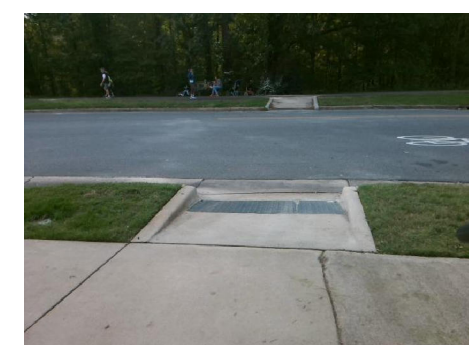
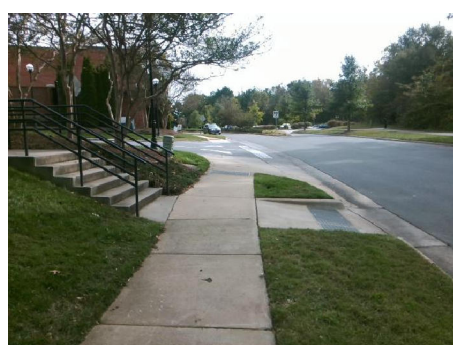
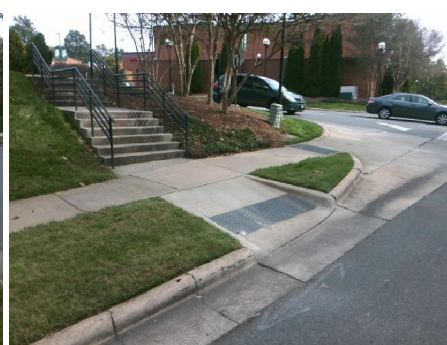
Compliance	Description	Data	Compliance	Description	Data
N/A	Ramp Length (in)	79.0	No	Ramp Slope (%)	14.1
Yes	Ramp Width (in)	67.0	Yes	Ramp XSlope (%)	1.0
N/A	Flare Type LT	N/A	N/A	Flare Type RT	N/A
N/A	Flare Slope LT (%)	N/A	N/A	Flare Slope RT (%)	N/A
N/A	Flare Traversable LT?	N/A	N/A	Flare Traversable RT?	N/A
N/A	Landing Length (in)	N/A	N/A	DWS Provided?	N/A
N/A	Landing Width (in)	N/A	N/A	DWS Contrast?	N/A
N/A	Landing Slope (%)	N/A	N/A	DWS Length (in)	N/A
N/A	Landing X Slope (%)	N/A	N/A	DWS Full Width?	N/A
N/A	Landing Curb? (Y/N)	N/A	N/A	DWS Offset (in)	N/A
N/A	Shared Landing?	N/A			
N/A	Gutter Ponding?	N/A	N/A	Gutter Slope (%)	N/A
N/A	Gutter Lip Ht (in)	N/A	N/A	Gutter X Slope (%)	N/A
N/A	Painted X Walk1?	No	N/A	Painted X Walk2?	N/A
	X Walk 1 Direction	To SW		X Walk 2 Direction	N/A
N/A	X Walk 1 Width (in)	N/A	N/A	X Walk 2 Width (in)	N/A
	X Walk 1 Slope (%)	3.7		X Walk 2 Slope (%)	N/A
	X Walk 1 X Slope (%)	2.5		X Walk 2 X Slope (%)	N/A

N/A	Ramp inside XWalk1?	N/A	N/A	Ramp inside XWalk2?	N/A
	Road Slope (%)	N/A	N/A	Clear Space?	N/A
	Road X Slope (%)	N/A	N/A	Clear Space to XWalk (in)	N/A
N/A	Any Obstructions?	N/A	N/A	Storm Grate/Utility Hazard?	N/A
	Obstruction Type			Storm Grate/Utility Type	
		N/A			N/A
			Yes	Surface Condition? (G/P)	Good

Remove & Replace Entire Ramp.
