# Access Compliance Report

## Public Rights-of-Way

### (Curb Ramps)

Intersection ID: 43642	Main Street: CEDAR_CROSSINGS_DR	Cross Street: HUNTINGTON_MEADOW_LN	Location: SW
ADA ID: CC712210FAC4	Ramp Type: PerpDiag	Initial Pass/Fail: Fail	Overall Compliance: No
Codes/Mitigation Info/Possible Solution			Severity Score: 35
			Field Measurements/Component Compliance

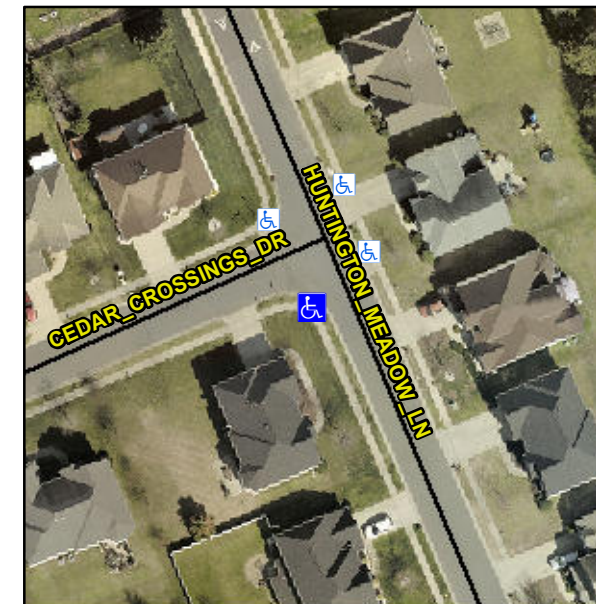
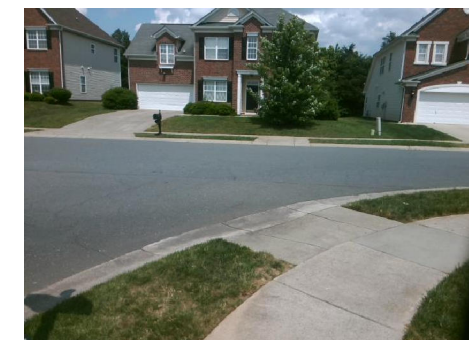
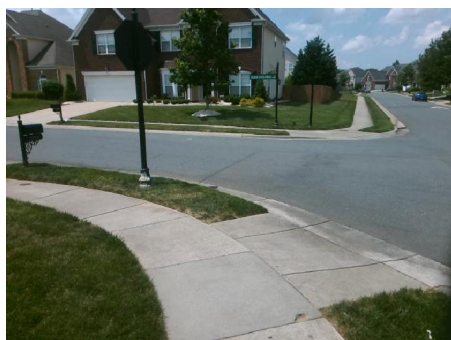
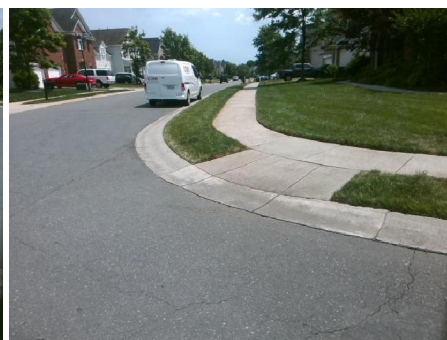
Compliance	Description	Data	Compliance	Description	Data
N/A	Ramp Length (in)	48.0	No	Ramp Slope (%)	13.8
No	Ramp Width (in)	40.0	No	Ramp XSlope (%)	2.6
N/A	Flare Type LT	N/A	N/A	Flare Type RT	N/A
N/A	Flare Slope LT (%)	N/A	N/A	Flare Slope RT (%)	N/A
N/A	Flare Traversable LT?	N/A	N/A	Flare Traversable RT?	N/A
N/A	Landing Length (in)	N/A	N/A	DWS Provided?	N/A
N/A	Landing Width (in)	N/A	N/A	DWS Contrast?	N/A
N/A	Landing Slope (%)	N/A	N/A	DWS Length (in)	N/A
N/A	Landing X Slope (%)	N/A	N/A	DWS Full Width?	N/A
N/A	Landing Curb? (Y/N)	N/A	N/A	DWS Offset (in)	N/A
N/A	Shared Landing?	N/A			
N/A	Gutter Ponding?	N/A	N/A	Gutter Slope (%)	N/A
N/A	Gutter Lip Ht (in)	N/A	N/A	Gutter X Slope (%)	N/A
N/A	Painted X Walk1?	No	N/A	Painted X Walk2?	No
	X Walk 1 Direction	To E		X Walk 2 Direction	To N
N/A	X Walk 1 Width (in)	N/A	N/A	X Walk 2 Width (in)	N/A
	X Walk 1 Slope (%)	3.3		X Walk 2 Slope (%)	0.9
	X Walk 1 X Slope (%)	2.0		X Walk 2 X Slope (%)	1.7

N/A	Ramp inside XWalk1?	N/A	N/A	Ramp inside XWalk2?	N/A
	Road Slope (%)	1.0	N/A	Clear Space?	N/A
	Road X Slope (%)	3.3	N/A	Clear Space to XWalk (in)	N/A
N/A	Any Obstructions?	N/A	N/A	Storm Grate/Utility Hazard?	N/A
	Obstruction Type			Storm Grate/Utility Type	
		N/A			N/A
			Yes	Surface Condition? (G/P)	Good

Possible Solutions:

**Remove & Replace Curb Ramp With Two New Directional Ramps or Equivalent.**

**Not Found, R304.5.1, R304.2.2, R304.5.3**
