Access Compliance Report

Public Rights-of-Way

(Curb Ramps)

Intersection ID: 48476	Main Street: FERNLEDGE_CT	Cross Street: AUTUMN_OAK_DR	Location: W
ADA ID: CC78E0E72E82	Ramp Type: Perp	Initial Pass/Fail: Fail	Overall Compliance: No
Severity Score: 33.75			
Codes/Mitigation Info/Possible Solution		Field Measurements/Component Compliance

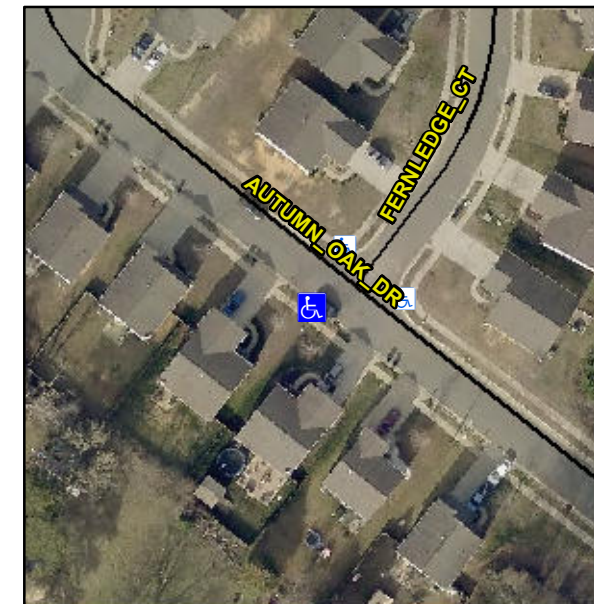
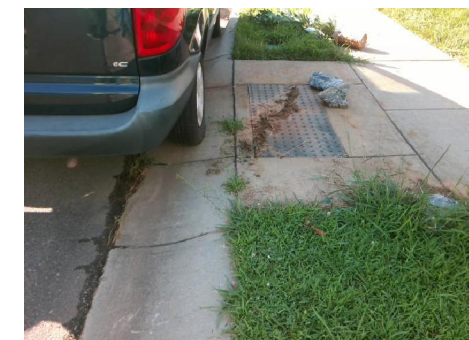
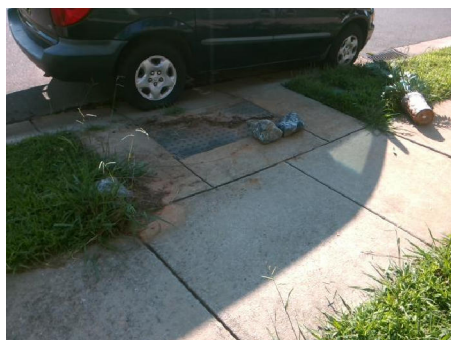
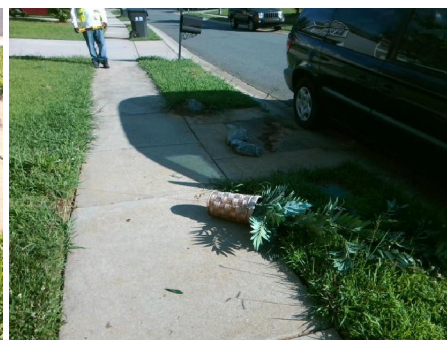
Not Found, R304.5.1, R304.2.2

Compliance	Description	Data	Compliance	Description	Data
N/A	Ramp Length (in)	48.0	No	Ramp Slope (%)	16.9
No	Ramp Width (in)	47.5	Yes	Ramp XSlope (%)	1.6
N/A	Flare Type LT	N/A	N/A	Flare Type RT	N/A
N/A	Flare Slope LT (%)	N/A	N/A	Flare Slope RT (%)	N/A
N/A	Flare Traversable LT?	N/A	N/A	Flare Traversable RT?	N/A
N/A	Landing Length (in)	N/A	N/A	DWS Provided?	N/A
N/A	Landing Width (in)	N/A	N/A	DWS Contrast?	N/A
N/A	Landing Slope (%)	N/A	N/A	DWS Length (in)	N/A
N/A	Landing X Slope (%)	N/A	N/A	DWS Full Width?	N/A
N/A	Landing Curb? (Y/N)	N/A	N/A	DWS Offset (in)	N/A
N/A	Shared Landing?	N/A			
N/A	Gutter Ponding?	N/A	N/A	Gutter Slope (%)	N/A
N/A	Gutter Lip Ht (in)	N/A	N/A	Gutter X Slope (%)	N/A
N/A	Painted X Walk1?	No	N/A	Painted X Walk2?	N/A
	X Walk 1 Direction	To NE		X Walk 2 Direction	N/A
N/A	X Walk 1 Width (in)	N/A	N/A	X Walk 2 Width (in)	N/A
	X Walk 1 Slope (%)	2.9		X Walk 2 Slope (%)	N/A
	X Walk 1 X Slope (%)	2.2		X Walk 2 X Slope (%)	N/A

N/A	Ramp inside XWalk1?	N/A	N/A	Ramp inside XWalk2?	N/A
	Road Slope (%)	N/A	N/A	Clear Space?	N/A
	Road X Slope (%)	N/A	N/A	Clear Space to XWalk (in)	N/A
N/A	Any Obstructions?	N/A	N/A	Storm Grate/Utility Hazard?	N/A
	Obstruction Type			Storm Grate/Utility Type	
		N/A			N/A
			Yes	Surface Condition? (G/P)	Good

Possible Solutions:

Remove & Replace Entire Ramp.
