## Access Compliance Report Public Rights-of-Way (Curb Ramps)

Lander -	014
Intersection ID: 10039485 Main Street: TELEVISION_PL		Cross Street: N/A					Location:	SW	
ADA ID: CC7E5219FBF8 Ramp Type: PerpDiag		Initial P	Initial Pass/Fail: Fail Overall Compliance: No				Severity Score:	72.5	
Codes/Mitigation Info/Possible Solution				Field Measurements/Component Compliance					
		Possible Solutions:		Compliance Description Date			a Compliance Description		Data
		Remove & Replace Curb Ramp Wit Two New Directional Ramps or Equivalent.	Vith	N/A	Ramp Length (in)	84.0	No	Ramp Slope (%)	8.4
				No	Ramp Width (in)	26.0	No	Ramp XSlope (%)	8.6
				N/A	Flare Type LT	N/A	N/A	Flare Type RT	N/A
				N/A	Flare Slope LT (%)	N/A	N/A	Flare Slope RT (%)	N/A
				N/A	Flare Traversable LT?	N/A	N/A	Flare Traversable RT?	N/A
the second of the				N/A	Landing Length (in)	N/A	N/A	DWS Provided?	N/A

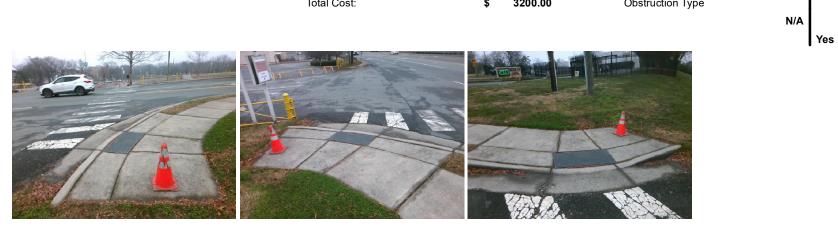
E.		Surveyor Notes:		N/A	Landing Width (in)	N/A	N/A	DWS Contrast?	N/A
		N/A		N/A	Landing Slope (%)	N/A	N/A	DWS Length (in)	N/A
				N/A	Landing X Slope (%)	N/A	N/A	DWS Full Width?	N/A
				N/A	Landing Curb? (Y/N)	N/A	N/A	DWS Offset (in)	N/A
				N/A	Shared Landing?	N/A			
A A A A A A A A A A A A A A A A A A A		PROW/ADA:		N/A	Gutter Ponding?	N/A	N/A	Gutter Slope (%)	N/A
		R304.5.1, R304.2.2, R304.5.3		N/A	Gutter Lip Ht (in)	N/A	N/A	Gutter X Slope (%)	N/A
		,		N/A	Painted X Walk1?	Yes	N/A	Painted X Walk2?	No
					X Walk 1 Direction	To SE		X Walk 2 Direction	To NE
				N/A	X Walk 1 Width (in)	91.0	N/A	X Walk 2 Width (in)	N/A
Street 1 Name	TELEVISION PL	-			X Walk 1 Slope (%)	4.1		X Walk 2 Slope (%)	4.7
Stop Condition-Street 2	None				X Walk 1 X Slope (%)	10.7		X Walk 2 X Slope (%)	3.2
Street 2 Name	ENTRANCE			N/A	Ramp inside XWalk1?	Yes	N/A	Ramp inside XWalk2?	N/A
Stop Condition-Street 1	None				Road Slope (%)	7.0	N/A	Clear Space?	N/A

Road X Slope (%)	9.9	N/A	Clear Space to XWalk (in)	N/A
				N/A	Any Obstructions?	N/A	N/A	Storm Grate/Utility Hazard?	N/A
		Total Cost: \$ 3	200.00		Obstruction Type			Storm Grate/Utility Type	
						N/A			N/A
